**PRE-DEMOLITION SURVEY**  
**FOR**  
**ASBESTOS-CONTAINING MATERIALS**  
**AT**  
**6840 CROSBY ROAD**  
**ALABAMA, NEW YORK**  
**MAY 2015**

Genesee County Economic  
Development Center  
99 MedTech Drive, Suite 106  
Batavia, New York 14020

**WATTS ARCHITECTURE & ENGINEERING**  
**95 PERRY STREET, SUITE 300**  
**BUFFALO, NEW YORK**

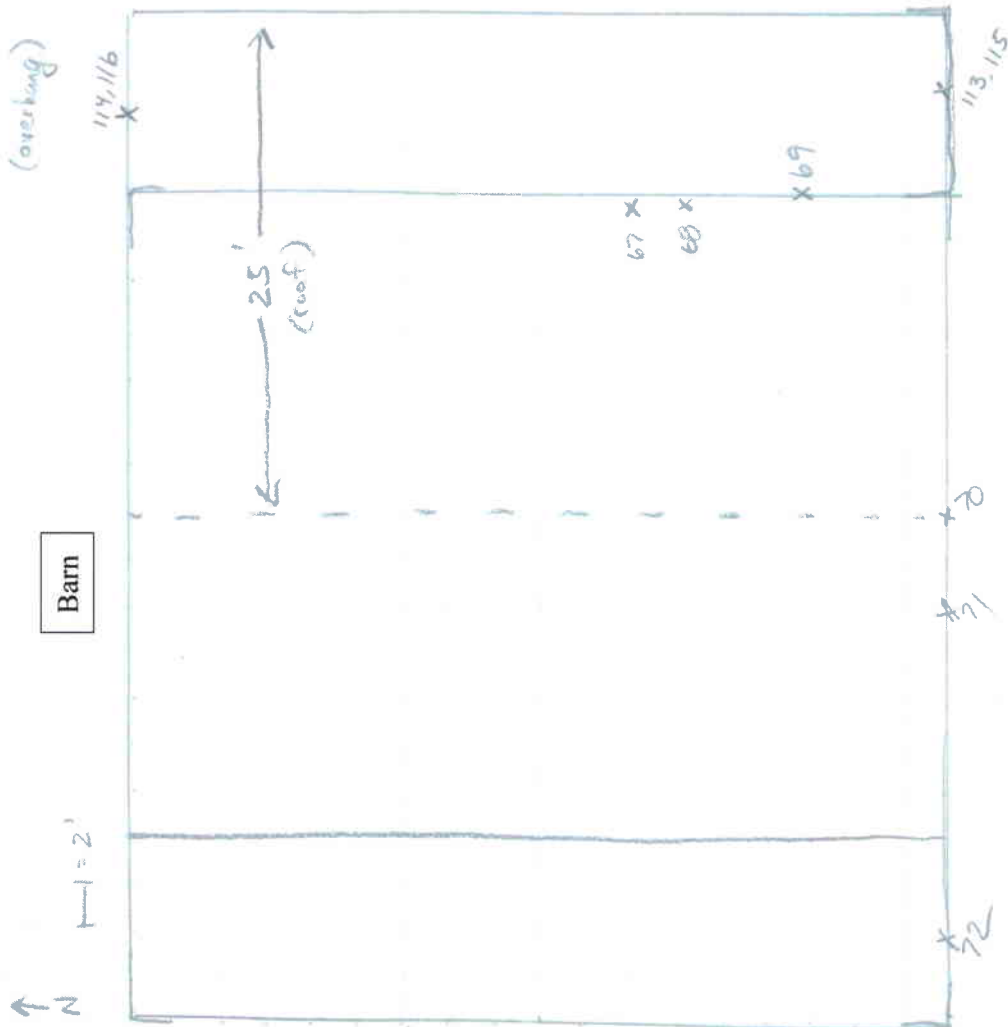
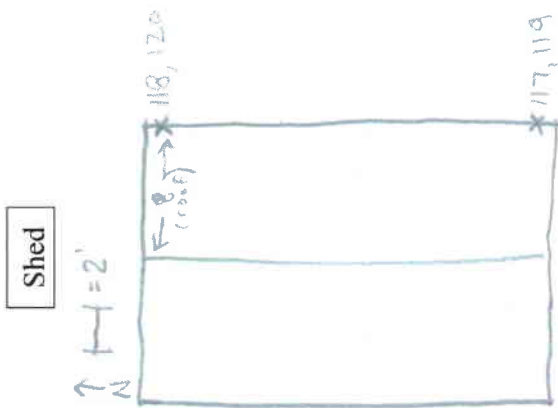
**FIGURE 2 – Approximate Sample Locations**

Barn and Shed  
6840 Crosby Road  
Town of Alabama, Genesee County, New York

All samples are prefixed with '13072.18 –'  
Collected on 4/20/2015 & 4/21/2015
