Re: STAMP Updated Wetland Delineation

# SCIENCE & TECHNOLOGY ADVANCED MANUFACTURING PARK (STAMP) AQUATIC RESOURCES DELINEATION UPDATE

## STAMP Delineation July 2026 Update Photo Report

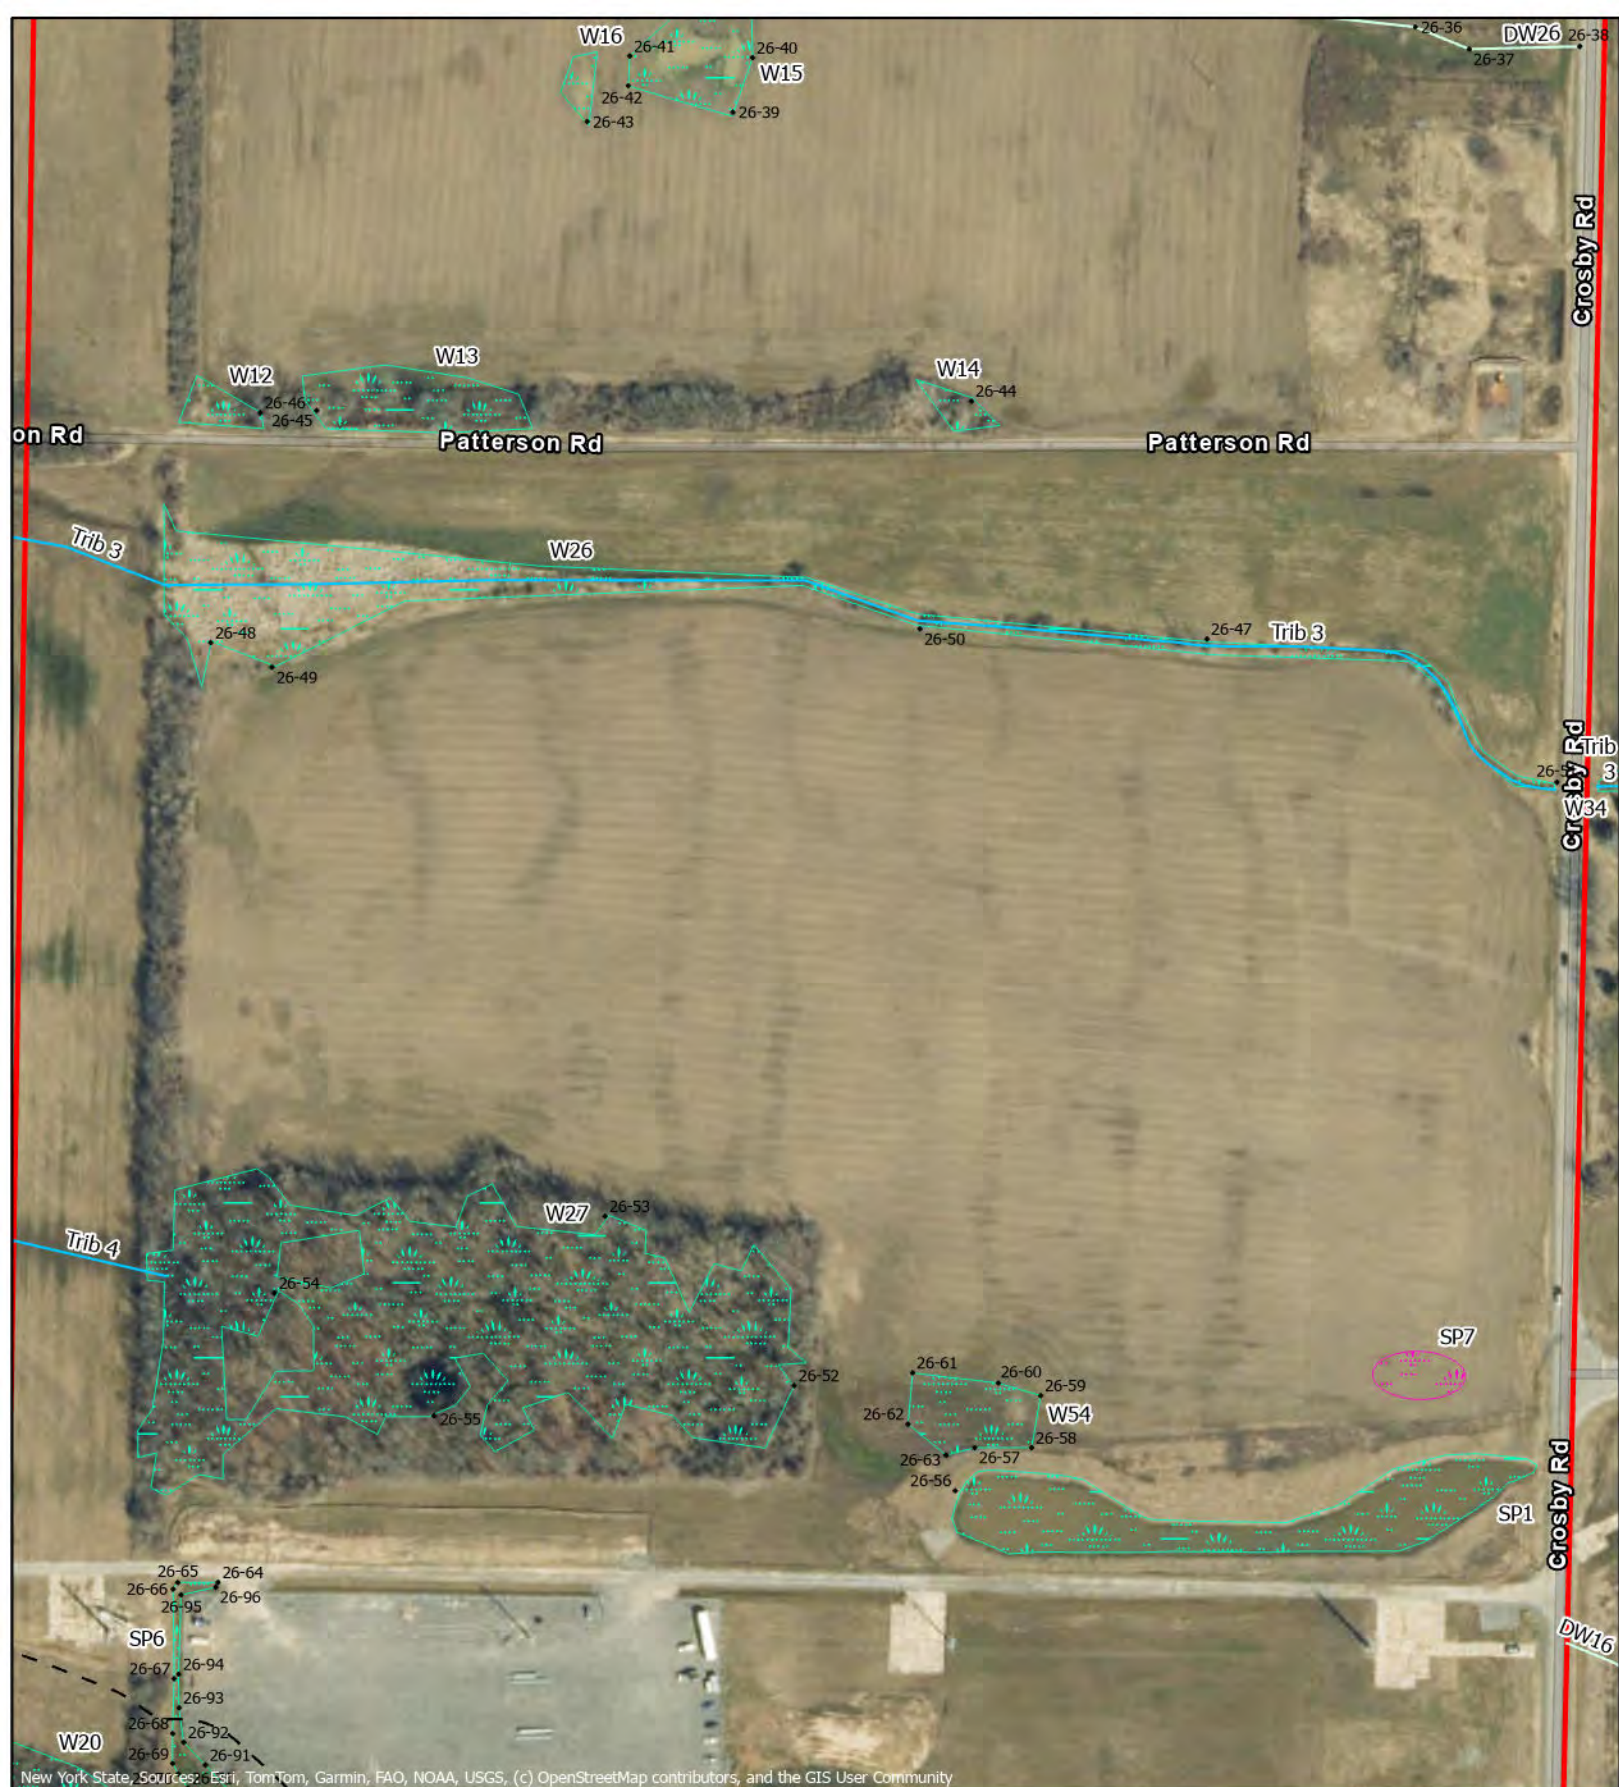
**Figure 7**  
 STAMP Wetland Delineation  
 Town of Alabama  
 Genesee County, New York  
 J. Lynch, Date: 7/22/2026

# Field Mapped Hydrologic Features

Six stormwater ponds have been constructed within the AOI since the 2017 delineation. Stormwater Pond 1 is the oldest, and was built during the construction of STAMP Drive. Stormwater Ponds 3 – 5 lie within the Plug Power site and were mapped via aerial imagery due to access restrictions. Stormwater Pond 6 was built as part of the National Grid laydown yard. Stormwater Pond 7 was constructed in summer 2025 in association with a large water tank. Access was not obtained for this delineation so the boundary could not be field verified although its location is noted on Figures 5 and 7.

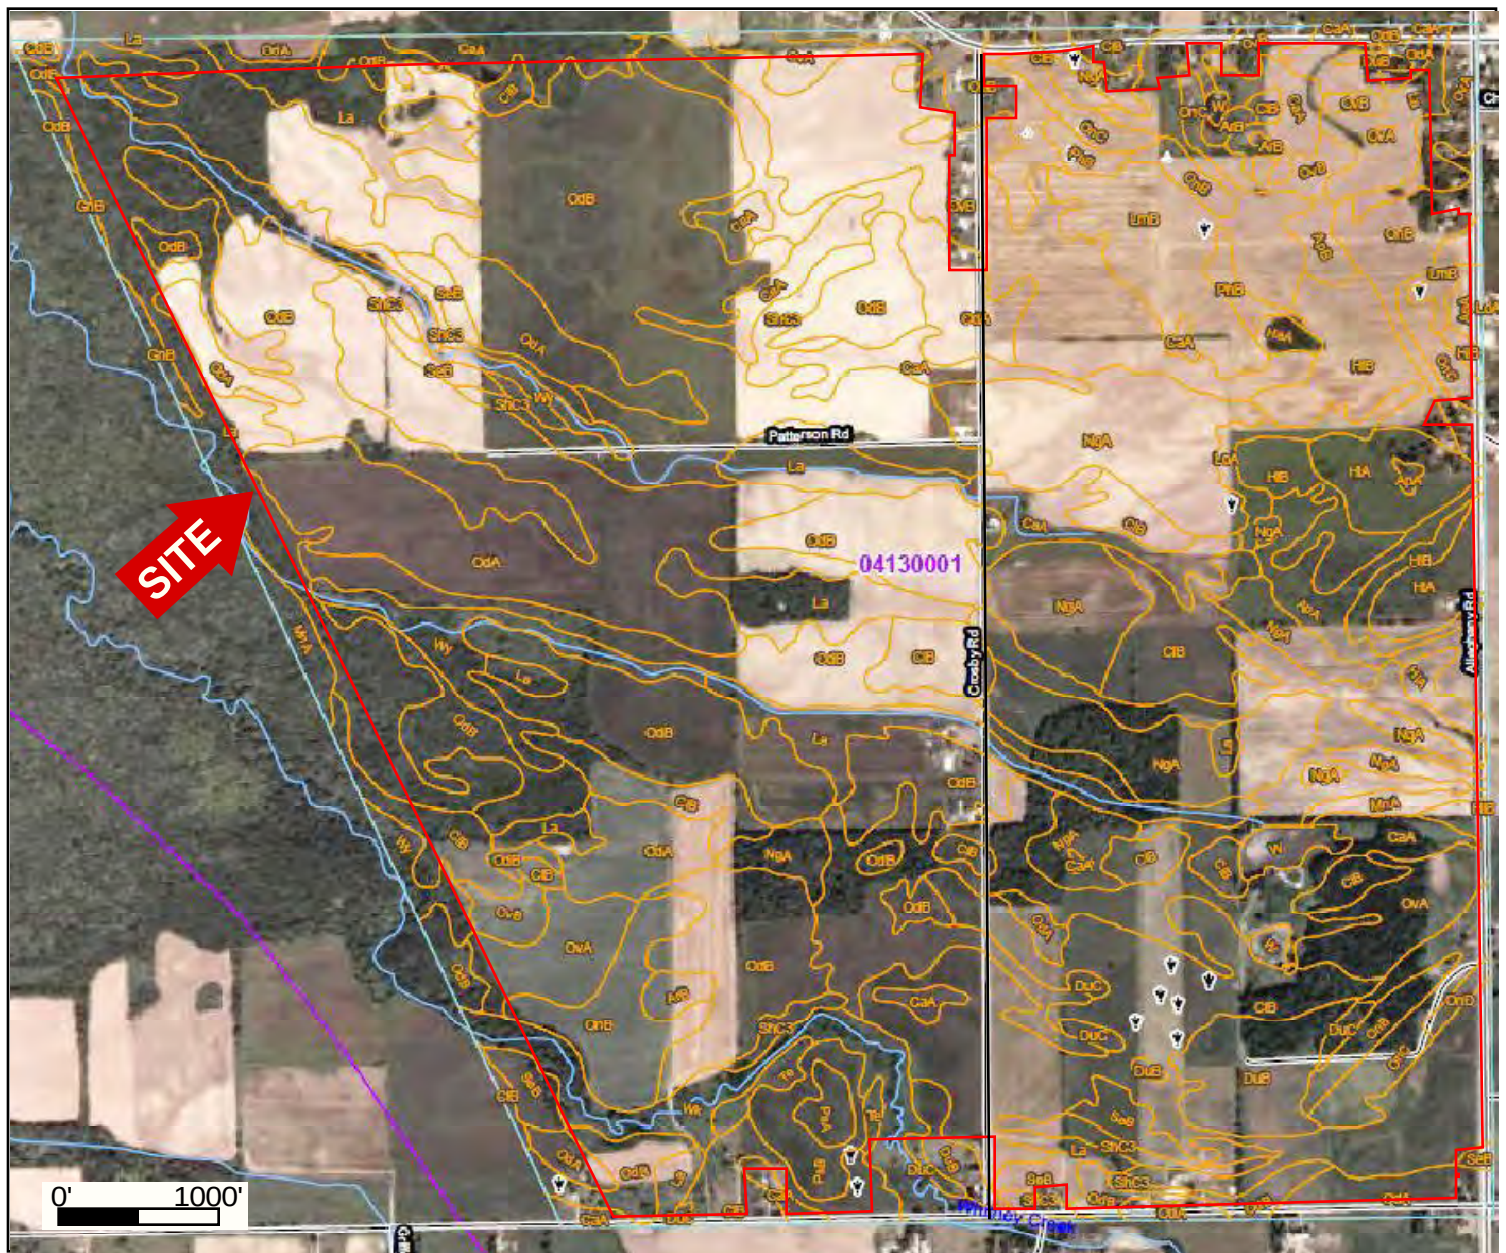
Figure 3: SCS Genesee County Soil Survey Map  
<http://websoilsurvey.nrcs.usda.gov/app/WebSoilSurvey.aspx>  
Site visited: 2/4/2010

Figure 3 presents the project area outlined on a copy of the Genesee County Soil Survey map from the National Cooperative Soil Survey. As shown on that figure, the site has the following soil types:

Field examination of the soil on the site showed general agreement to the published NRCS soil map (Figure 3). The upland areas of the project site were determined to be underlain by Appleton silt loam, Arkport very fine sandy loam, Collamer silt loam, Dunkirk silt loam, Galen very fine sandy loam, Hilton loam, Lakemont silty clay loam, Lima silt loam, Minoa very fine sandy loam, Niagara silt loam, Odessa silt loam, Ontario loam, Ovid silt loam, Palmyra gravelly loam, Phelps gravelly loam, Schoharie silt loam, Teel silt loam, Wakeville silt loam, Wayland silt loam and soil fill (Udorthents). The wetland areas were underlain by Lakemont silty clay loam, Odessa silt loam, Canandaigua silty clay loam, Wayland silt loam, Collamer silt loam, Niagara silt loam, Ovid silt loam, Halsey silt loam, Hilton loam, Niagara silt loam, Canandaigua silt loam, and Lyons silt loam.

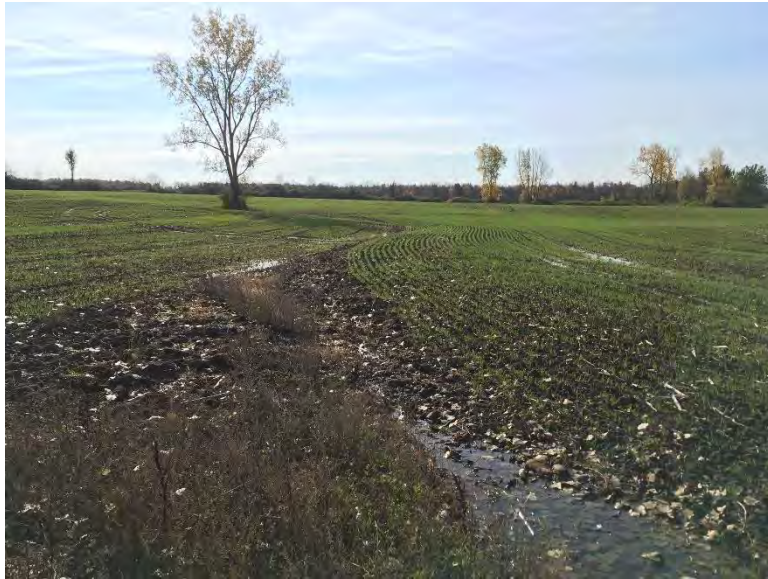
Trib 3 – N end

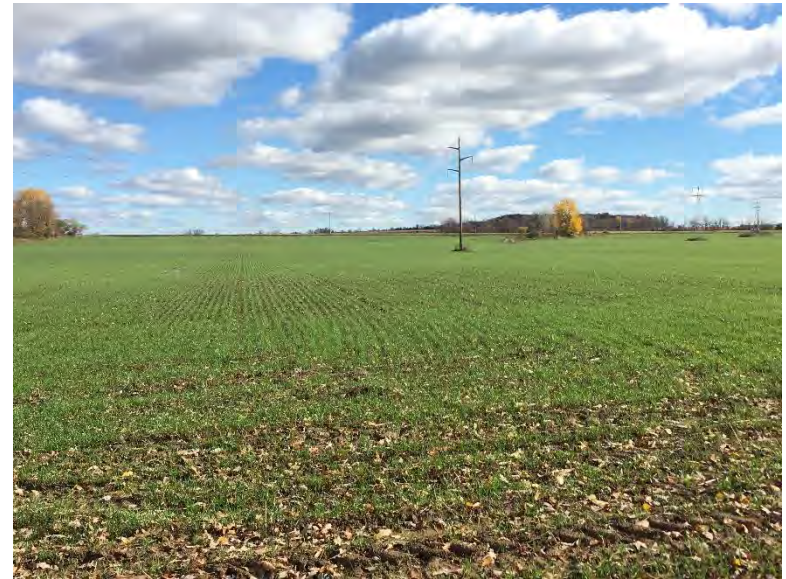
Trib 3 – S end Change

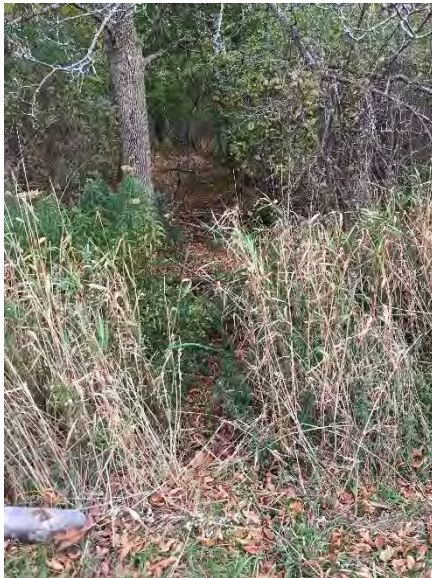
Trib 4 at exit from 27-3

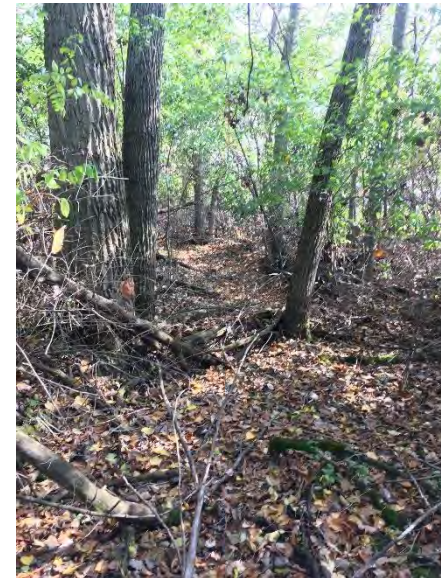
Trib 4 – N of 19

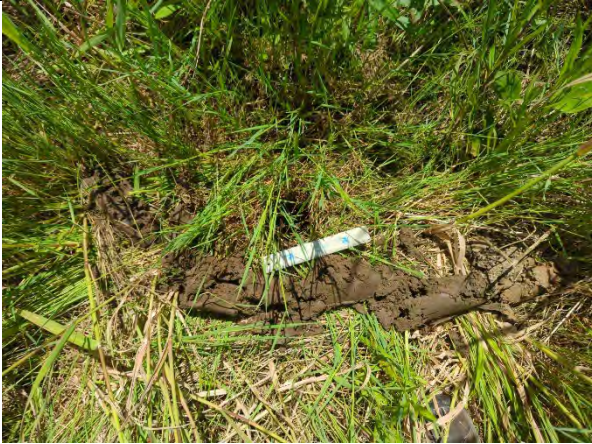
**Photo 1**  
DP1, Wetland 10, Soils.

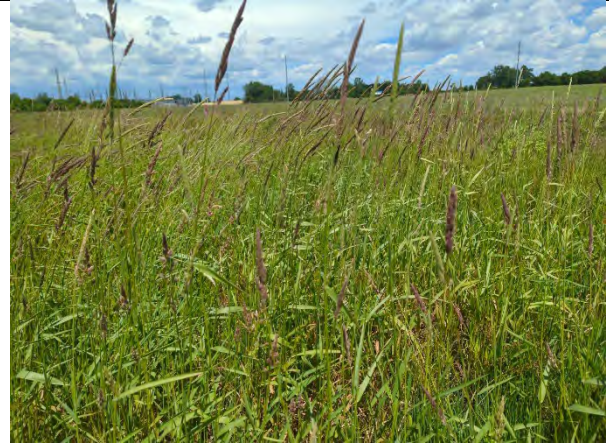
**Photo 2**  
DP1, Wetland 10, facing north.

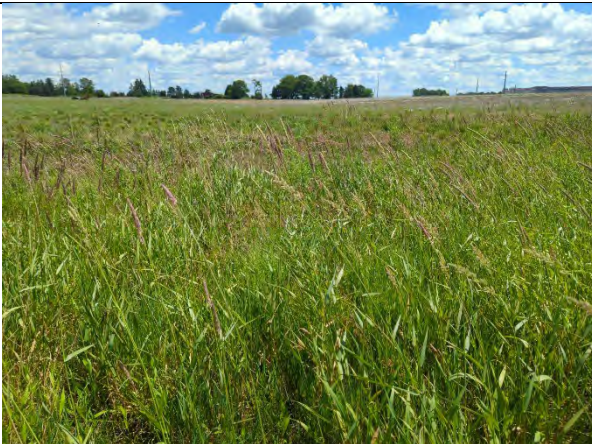
**Photo 3**  
DP1, Wetland 10, facing east.

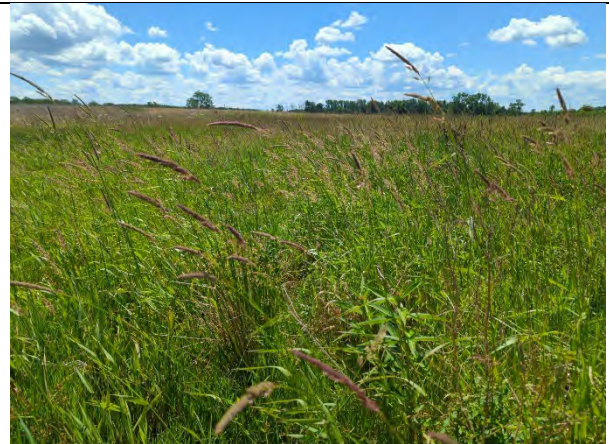
**Photo 4**  
DP1, Wetland 10, facing south.

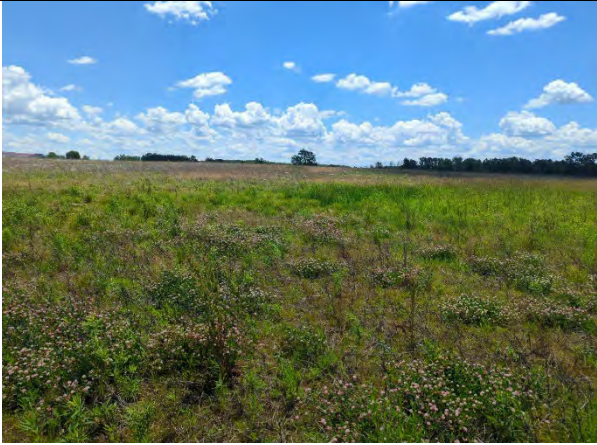
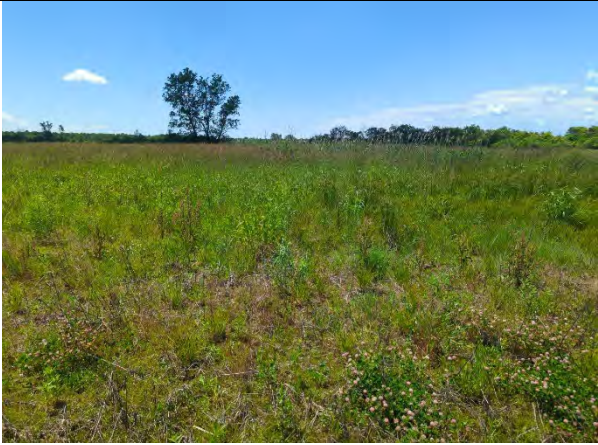
| <p><b>Photo 9</b><br/>DP2, Upland adjacent to Wetland 10,<br/>facing south.</p> | <p><b>Photo 10</b><br/>DP2, Upland adjacent to Wetland 10,<br/>facing west.</p> |

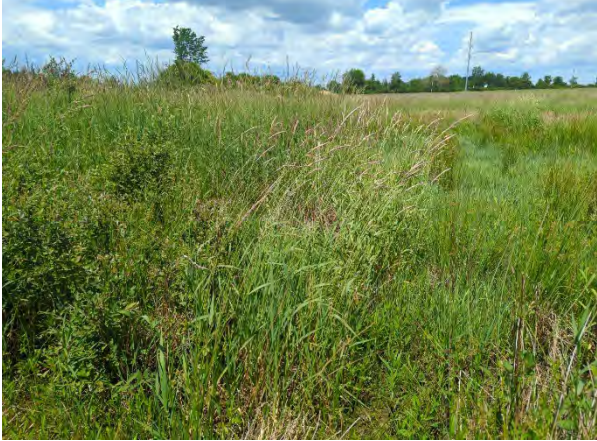
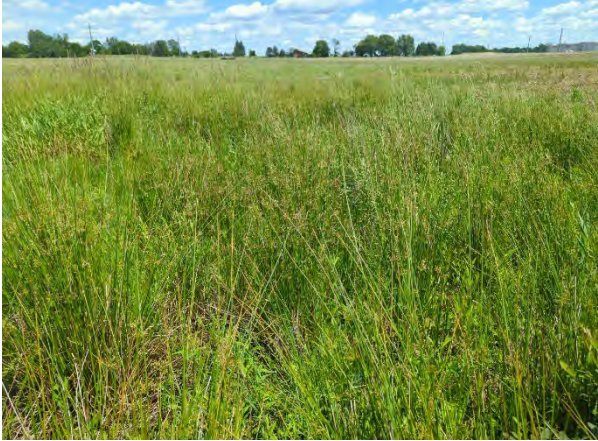
| <p><b>Photo 11</b><br/>DP3, Wetland 53, facing north.</p> | <p><b>Photo 12</b><br/>DP3, Wetland 53, facing east.</p> |

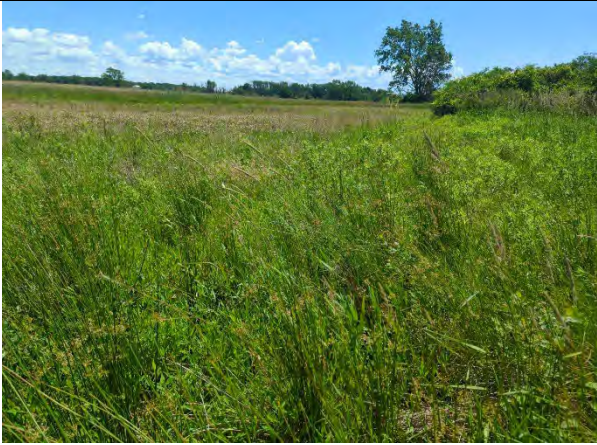
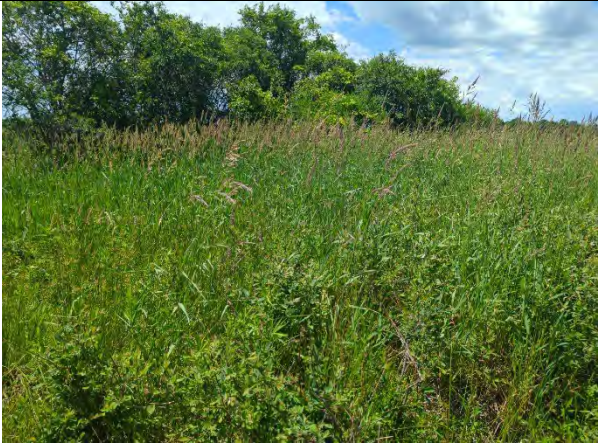
| <p><b>Photo 13</b><br/>DP3, Wetland 53, facing south.</p> | <p><b>Photo 14</b><br/>DP3, Wetland 53, facing west.</p> |

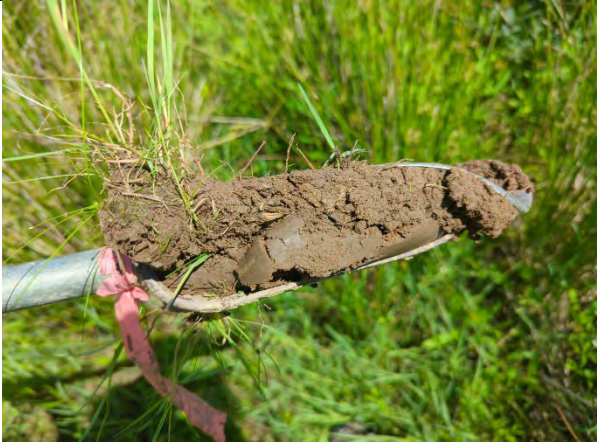
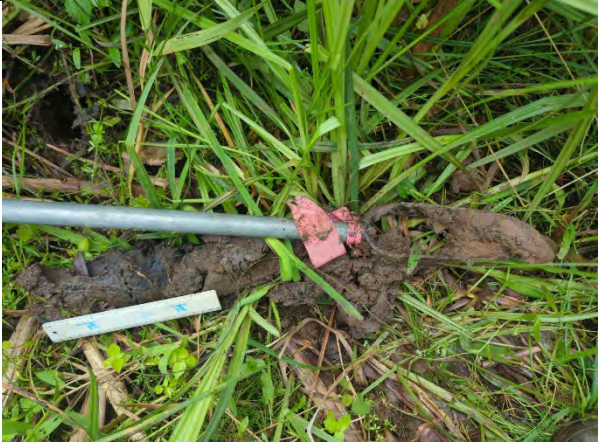
| <p><b>Photo 15</b><br/>DP3, Wetland 53, Soils.</p> | <p><b>Photo 16</b><br/>DP4, Wetland 20, Soils.</p> |

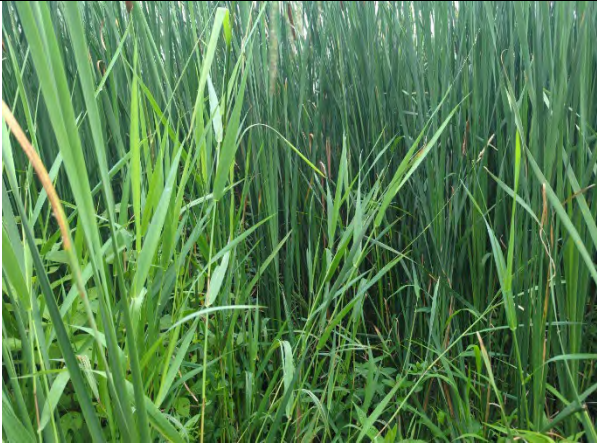
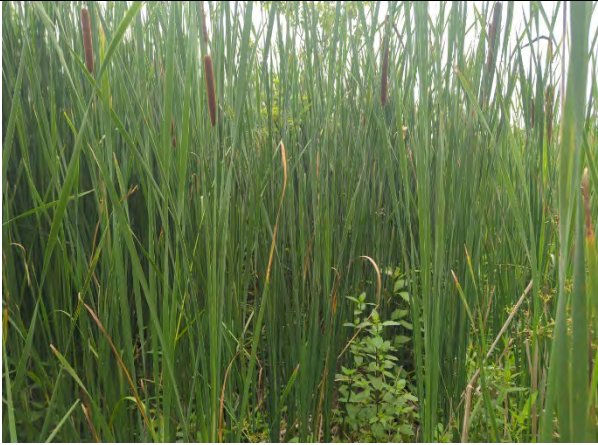
| <p><b>Photo 17</b><br/>DP4, Wetland 20, facing north.</p> | <p><b>Photo 18</b><br/>DP4, Wetland 20, facing east.</p> |

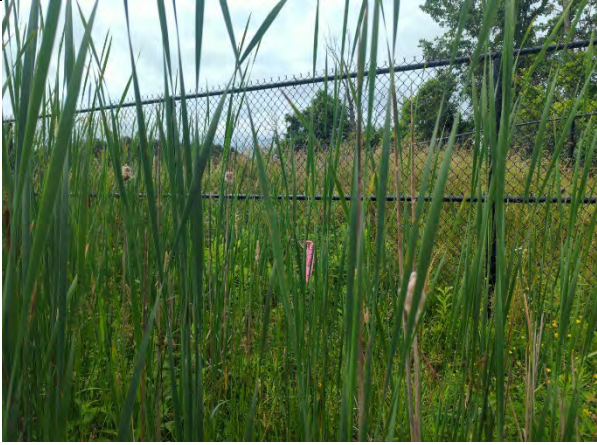
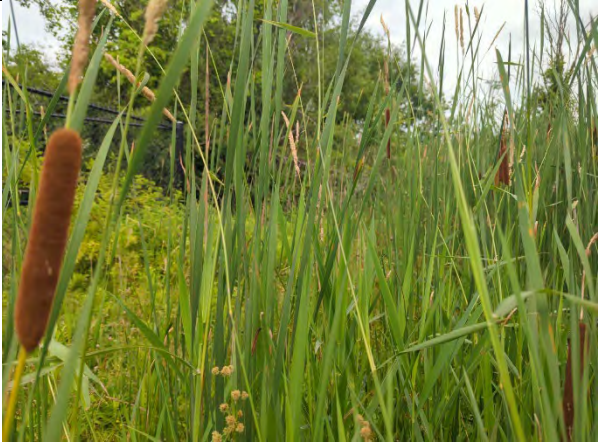
| <p><b>Photo 19</b><br/>DP4, Wetland 20, facing south.</p> | <p><b>Photo 20</b><br/>DP4, Wetland 20, facing west.</p> |

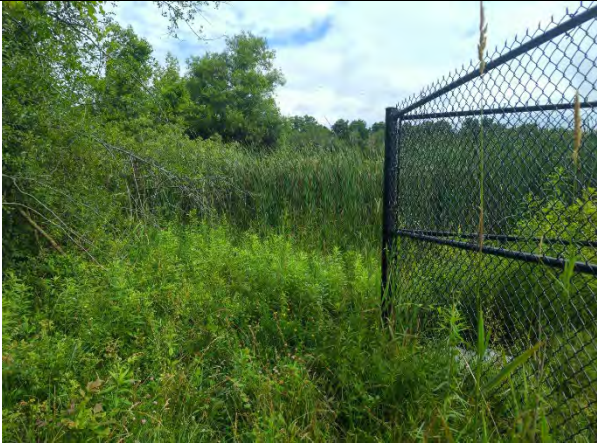
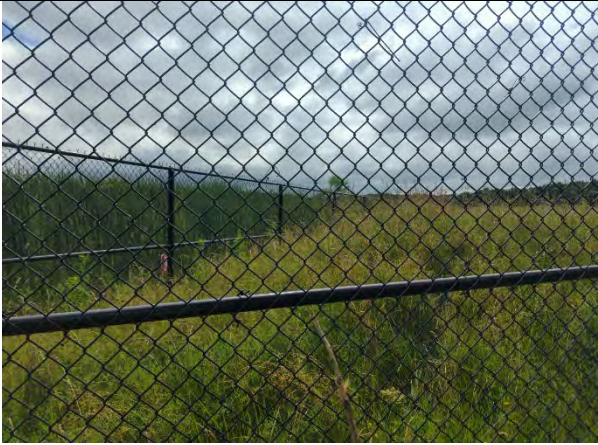
| <p><b>Photo 21</b><br/>DP5, Upland adjacent Wetland 20, facing north.</p> | <p><b>Photo 22</b><br/>DP5, Upland adjacent Wetland 20, facing east.</p> |

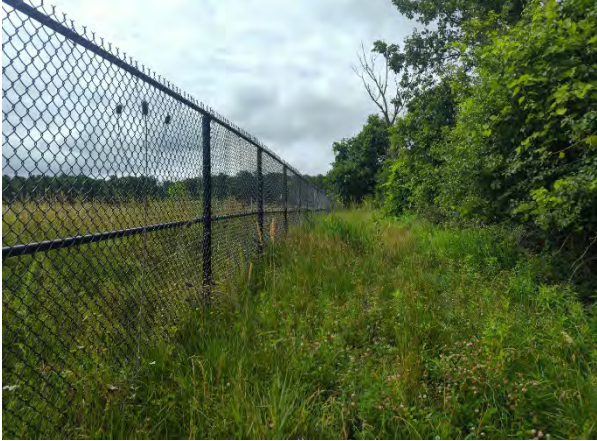
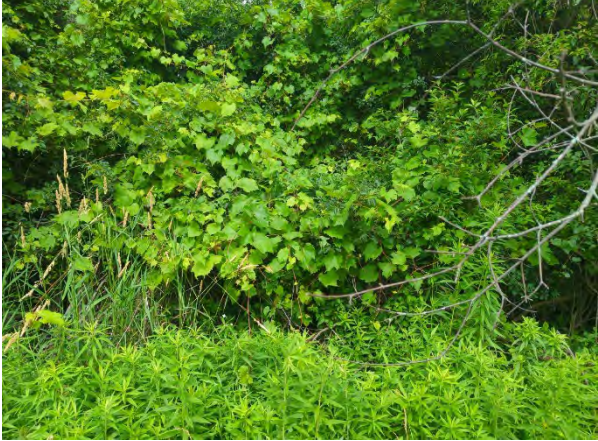
| <p><b>Photo 23</b><br/>DP5, Upland adjacent Wetland 20, facing south.</p> | <p><b>Photo 24</b><br/>DP5, Upland adjacent Wetland 20, facing west.</p> |

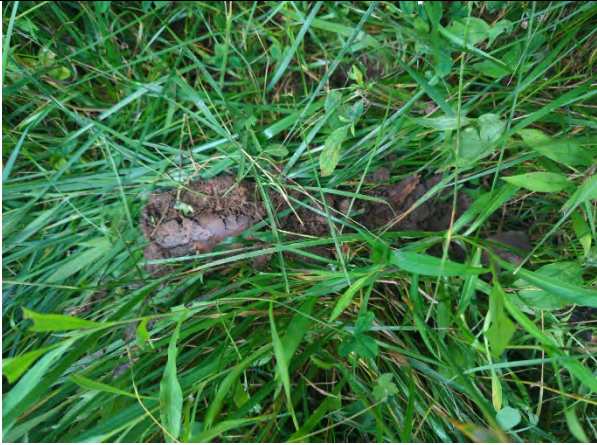
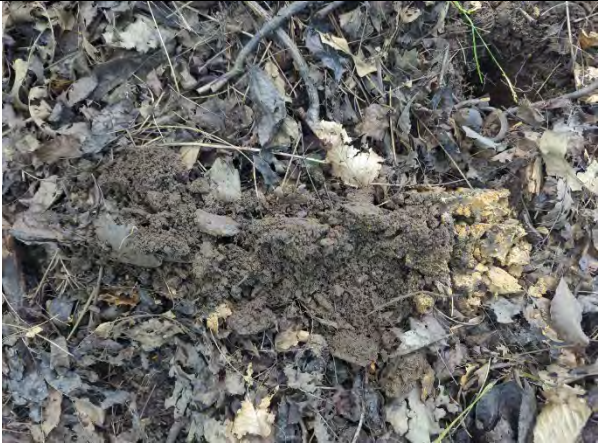
| <p><b>Photo 25</b><br/>DP5, Upland adjacent Wetland 20, Soils.</p> | <p><b>Photo 26</b><br/>DP6, Wetland 29, Soils.</p> |

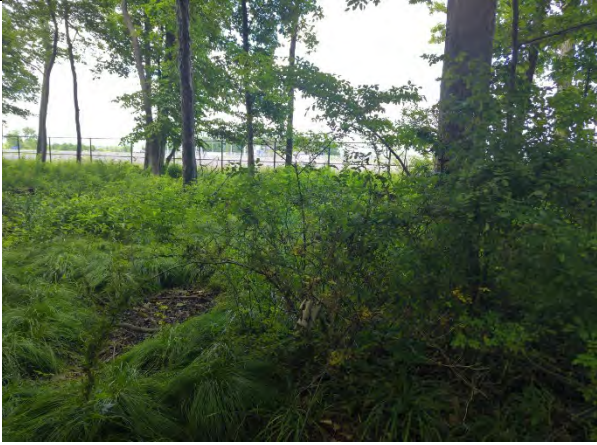
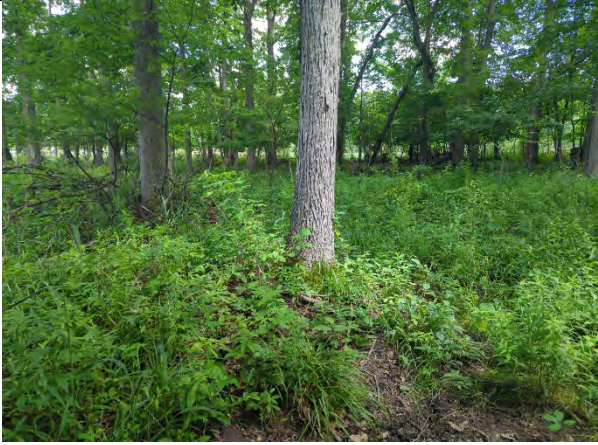
| <p><b>Photo 27</b><br/>DP6, Wetland 29, facing north.</p> | <p><b>Photo 28</b><br/>DP6, Wetland 29, facing east.</p> |

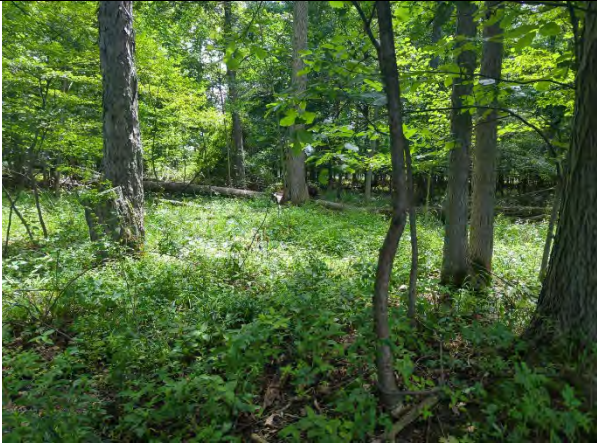
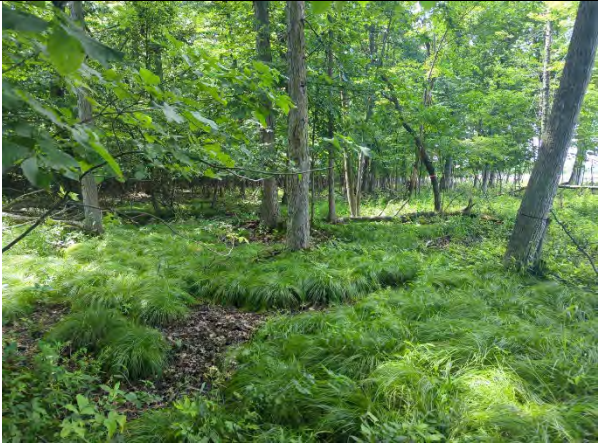
| <p><b>Photo 29</b><br/>DP6, Wetland 29, facing south.</p> | <p><b>Photo 30</b><br/>DP6, Wetland 29, facing west.</p> |

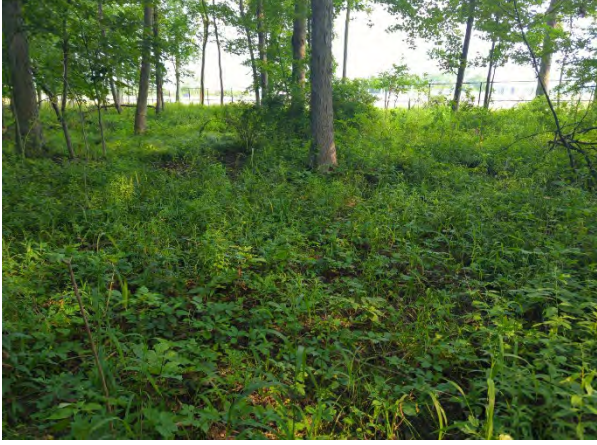
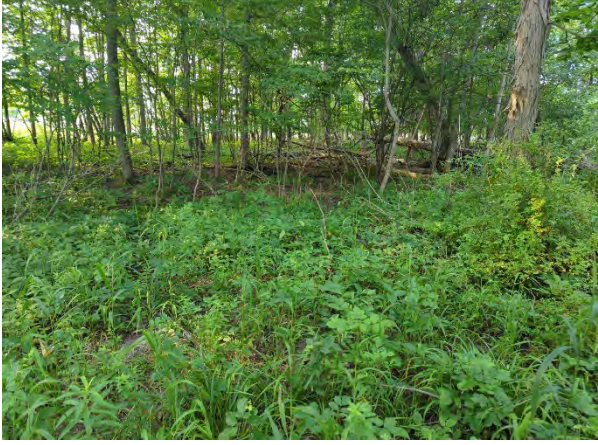
| <p><b>Photo 31</b><br/>DP7, Upland adjacent to Wetland 29,<br/>facing northwest.</p> | <p><b>Photo 32</b><br/>DP7, Upland adjacent to Wetland 29,<br/>facing southeast.</p> |

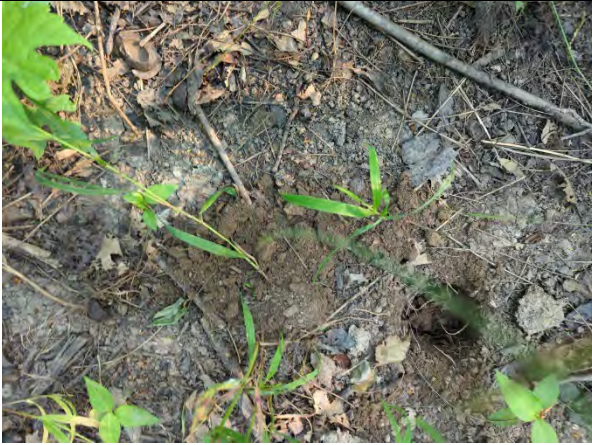
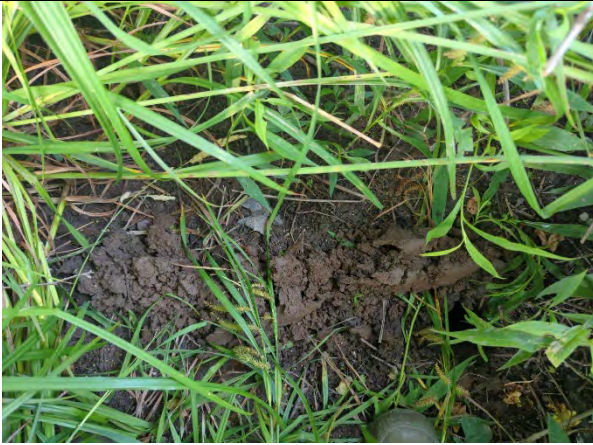
| <p><b>Photo 33</b><br/>DP7, Upland adjacent to Wetland 29, Soils.</p> | <p><b>Photo 34</b><br/>DP8, Wetland 20, Soils.</p> |

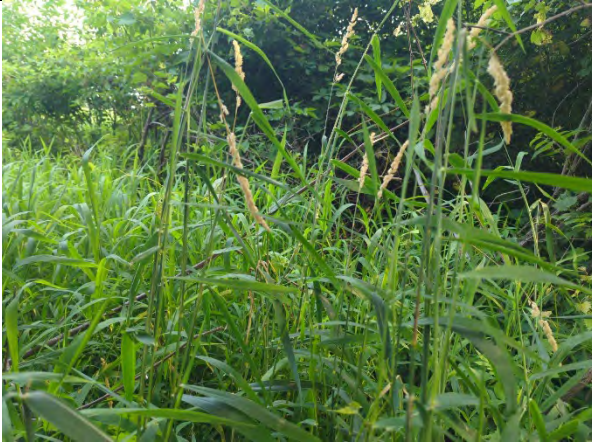
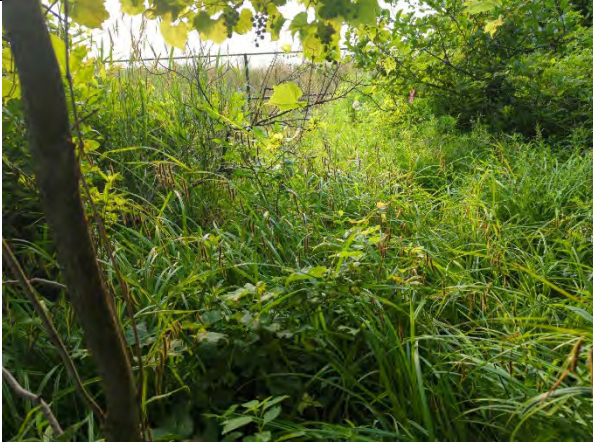
| <p><b>Photo 35</b><br/>DP8, Wetland 20, facing north.</p> | <p><b>Photo 36</b><br/>DP8, Wetland 20, facing east.</p> |

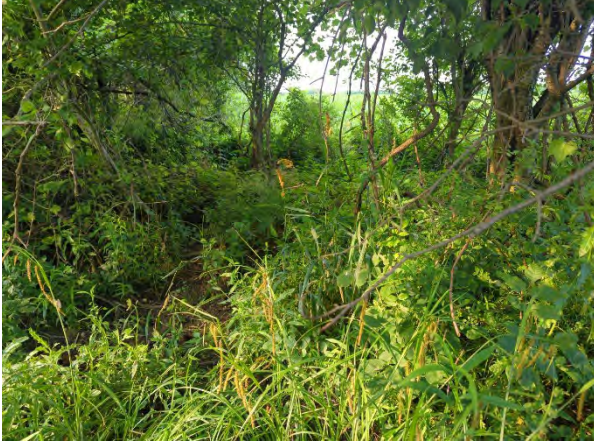
**Photo 37**

DP8, Wetland 20, facing south.

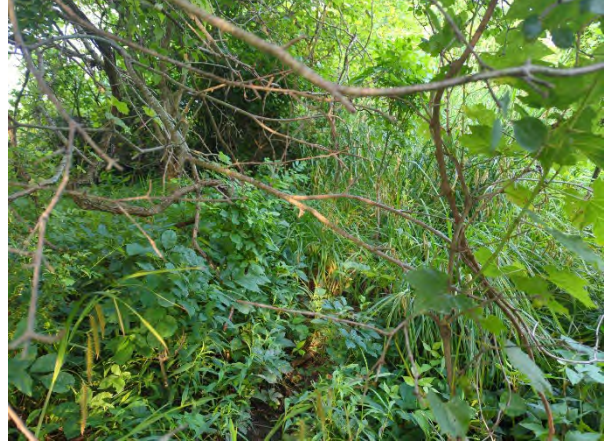
**Photo 38**

DP8, Wetland 20, facing west.

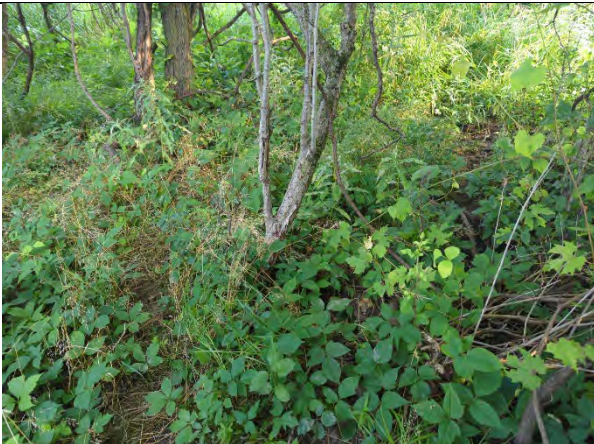
**Photo 39**

DP9, adjacent to Wetland 20, facing north.

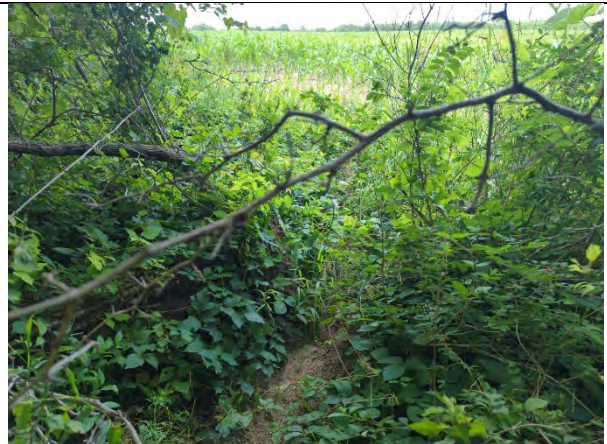
**Photo 40**

DP9, adjacent to Wetland 20, facing south.

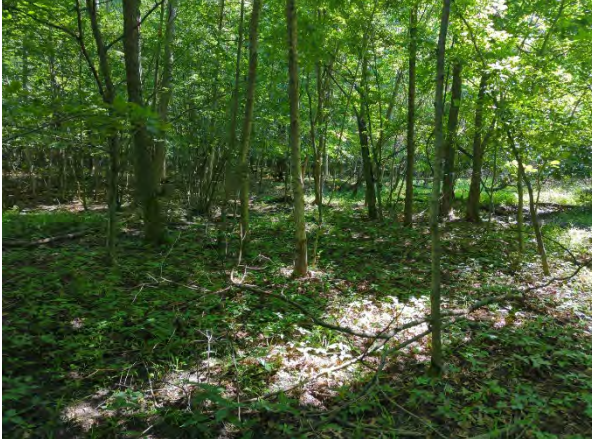
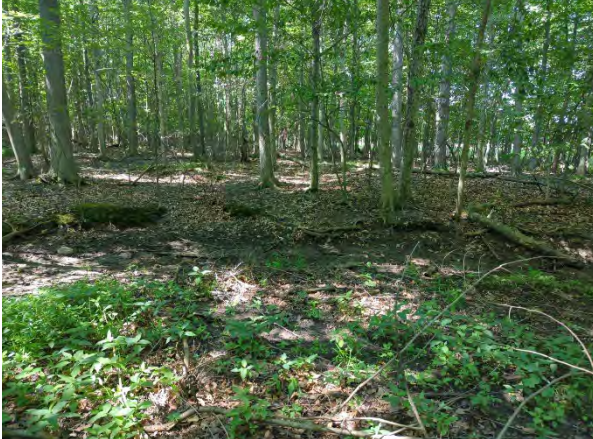
| <p><b>Photo 41</b><br/>DP10, Wetland 36, facing northeast.</p> | <p><b>Photo 42</b><br/>DP10, Wetland 36, facing southwest.</p> |

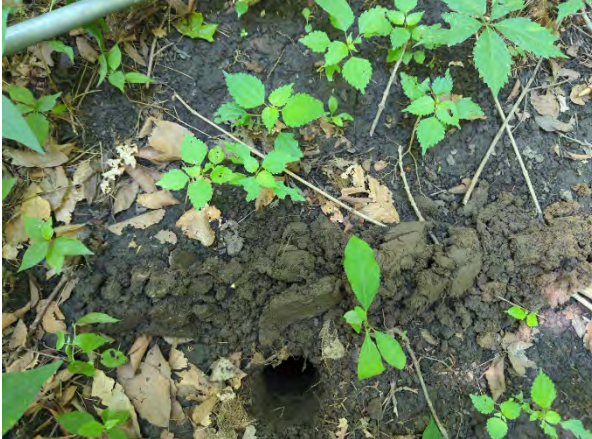
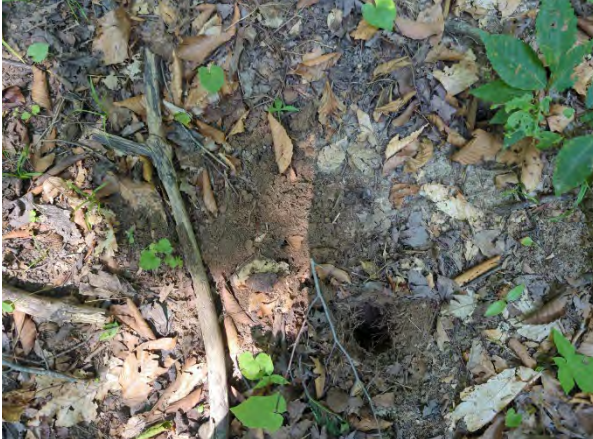
| <p><b>Photo 43</b><br/>DP10, Wetland 36, Soils.</p> | <p><b>Photo 44</b><br/>DP11, adjacent to Wetland 36, Soils.</p> |

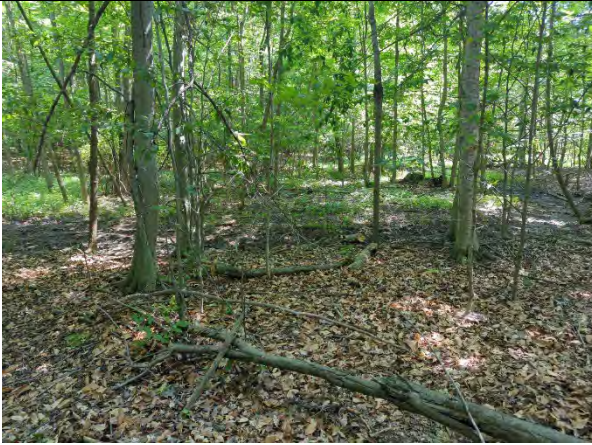
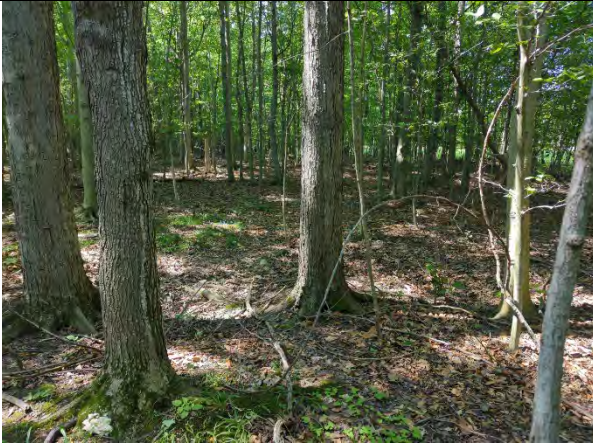
| <p><b>Photo 45</b><br/>DP11, adjacent to Wetland 36, facing northeast.</p> | <p><b>Photo 46</b><br/>DP11, adjacent to Wetland 36, facing south.</p> |

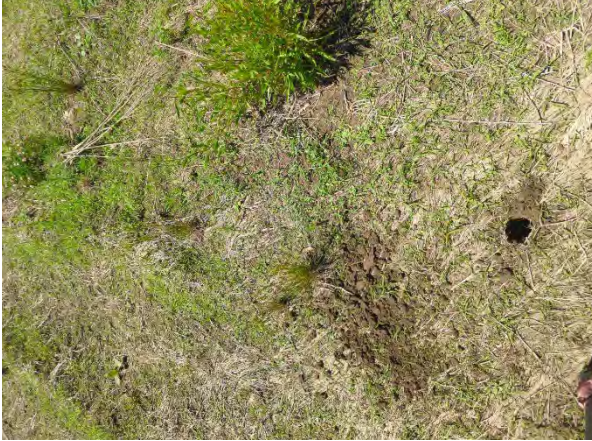
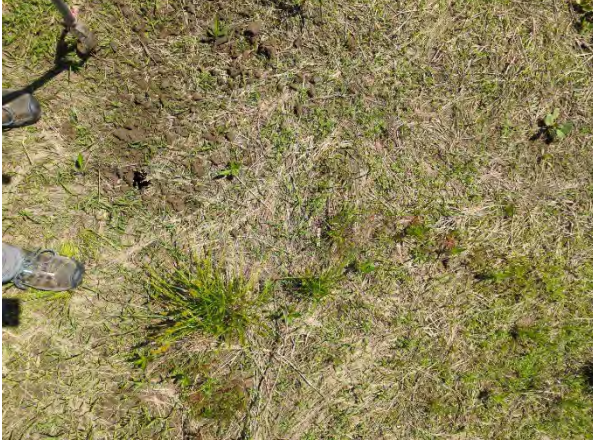
| <p><b>Photo 47</b><br/>Spot check 1 adjacent to Wetland 10. No hydric soils present.</p> | <p><b>Photo 48</b><br/>Spot check 2 adjacent to Wetland 10. No hydric soils present.</p> |

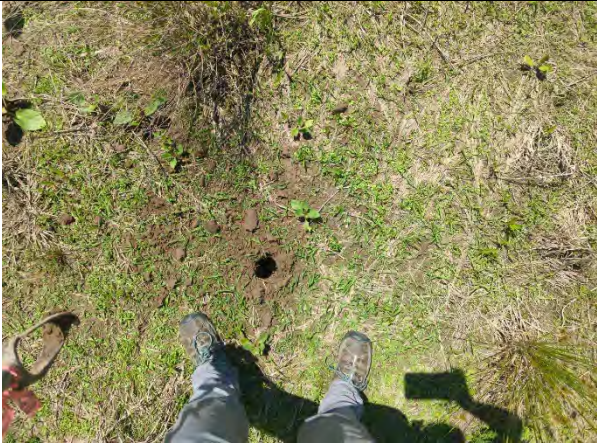
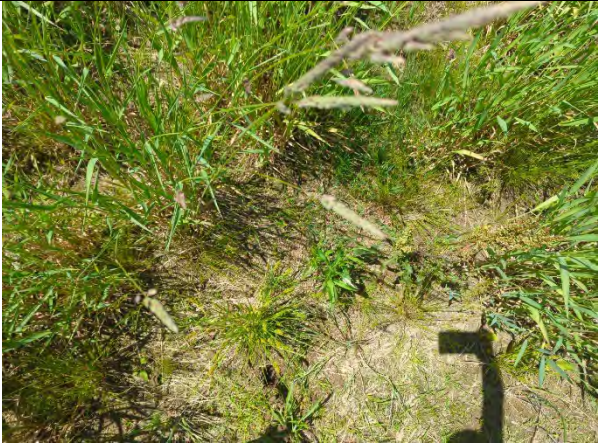
| <p><b>Photo 49</b></p> <p>Spot check 3 adjacent to Wetland 10. No hydric soils present.</p> | <p><b>Photo 50</b></p> <p>Spot check 4 adjacent to Wetland 10. No hydric soils present.</p> |

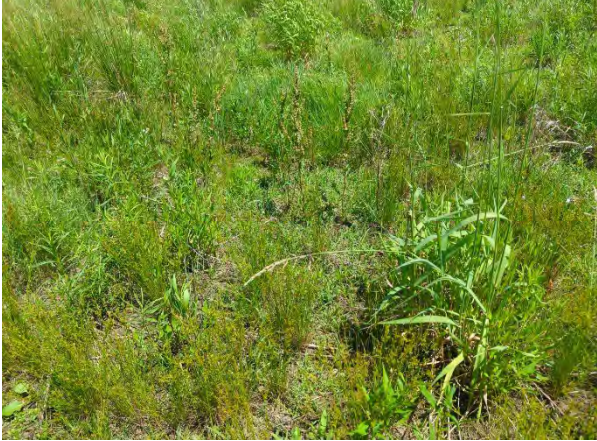
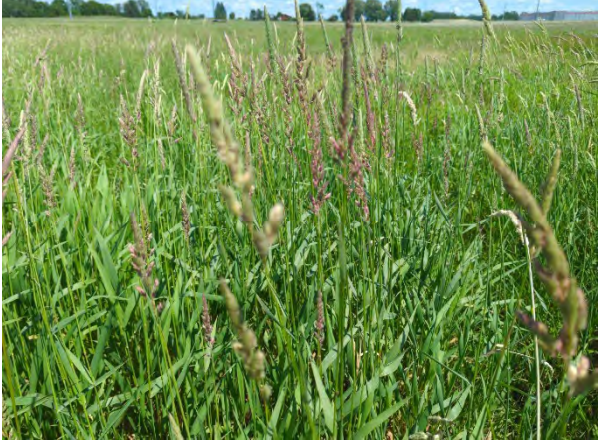
| <p><b>Photo 51</b></p> <p>Spot check 5 adjacent to Wetland 10. No hydric soils present.</p> | <p><b>Photo 52</b></p> <p>Spot check 6 adjacent to Wetland 53. No hydric soils present.</p> |

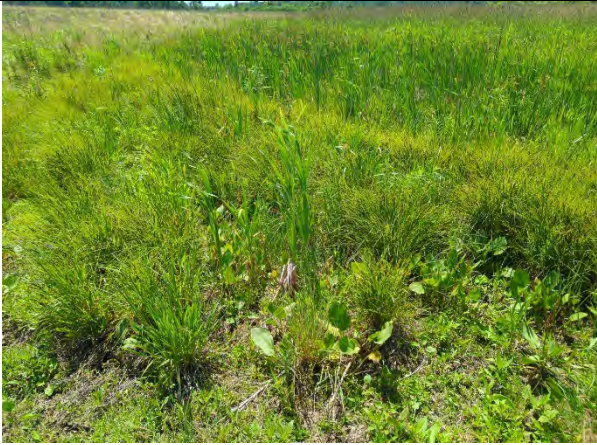
| <p><b>Photo 53</b><br/>Waypoint 26-7, Wetland 10, facing south.</p> | <p><b>Photo 54</b><br/>Waypoint 26-10, Wetland 10, facing northwest.</p> |

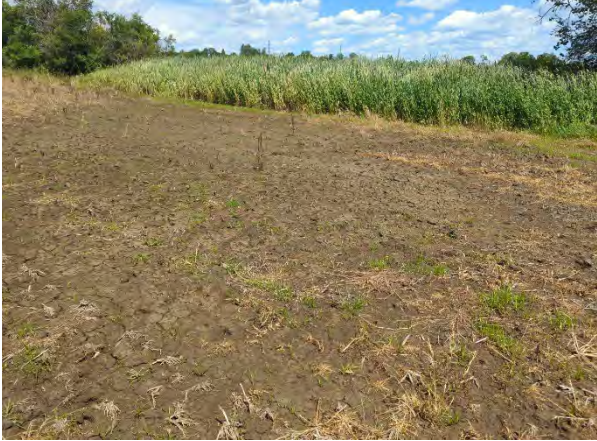
| <p><b>Photo 55</b><br/>Waypoint 26-13, Wetland 10, facing east.<br/>The wetland now extends into the active farm field.</p> | <p><b>Photo 56</b><br/>Waypoint 26-13, Tributary 2, facing west.</p> |

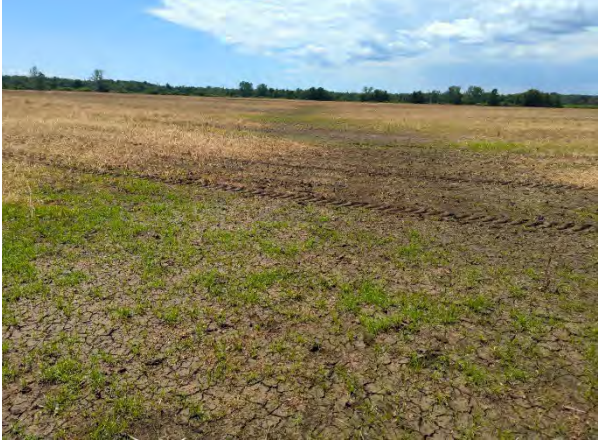
| Identifier | Length in AOI<br>(Linear Feet) | Flow Regime & Direction | Jurisdiction | Photos |
|---|---|---|---|---|
| Trib 2 | 234.89 | Intermittent; Flows from W10 to the NW | USACE | Photo 56 |

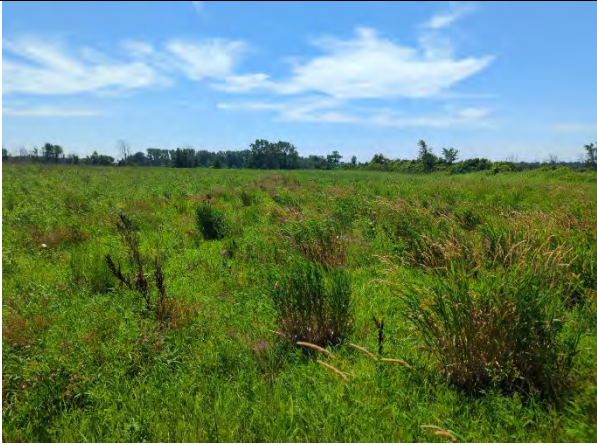
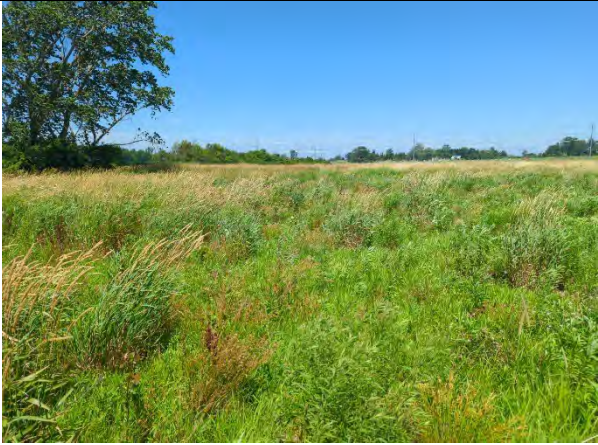
| <p><b>Photo 57</b><br/>Waypoint 26-23, Drainage Way 26, facing south.</p> | <p><b>Photo 58</b><br/>Waypoint 26-23, Drainage Way 26, facing north towards Wetland 10.</p> |

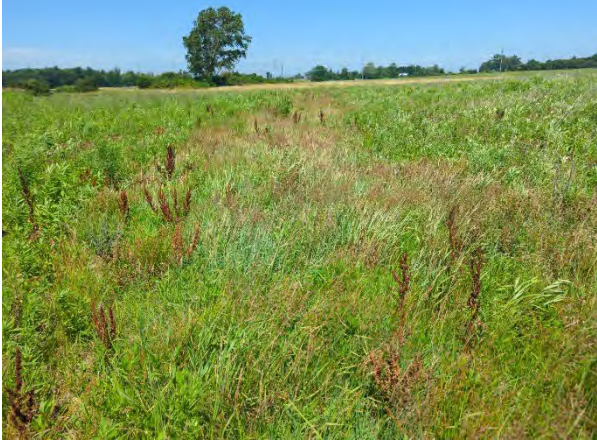
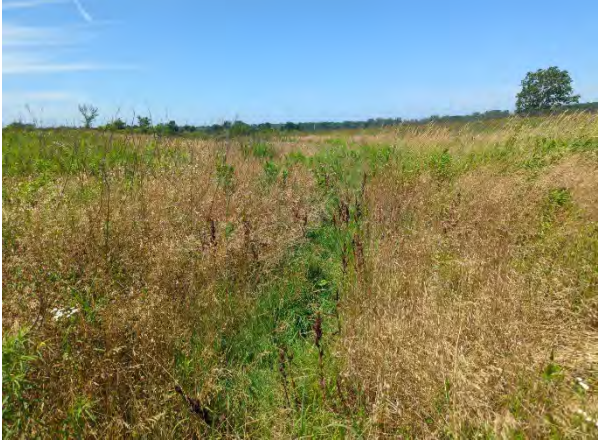
| <p><b>Photo 59</b><br/>Waypoint 26-25, Drainage Way 26, facing north.</p> | <p><b>Photo 60</b><br/>Waypoint 26-29, Drainage Way 26, facing northwest.</p> |

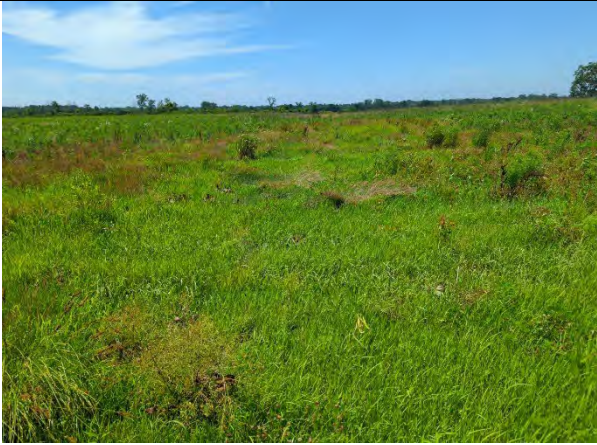
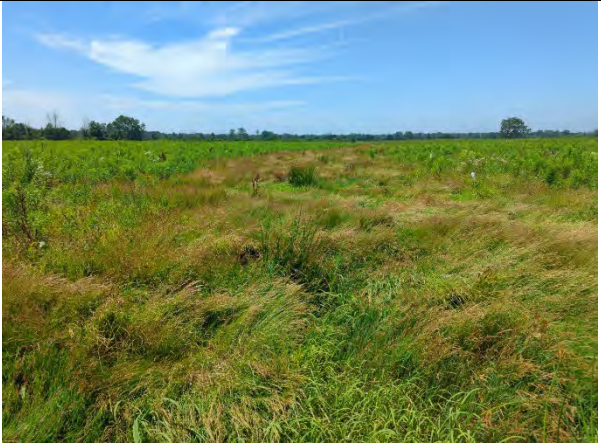
| <p><b>Photo 61</b><br/>Waypoint 26-31, Drainage Way 26, facing west.</p> | <p><b>Photo 62</b><br/>Waypoint 26-34, Drainage Way 26, facing west.</p> |
