Re: STAMP Updated Wetland Delineation

# SCIENCE & TECHNOLOGY ADVANCED MANUFACTURING PARK (STAMP) AQUATIC RESOURCES DELINEATION UPDATE

## STAMP Delineation July 2026 Update Photo Report

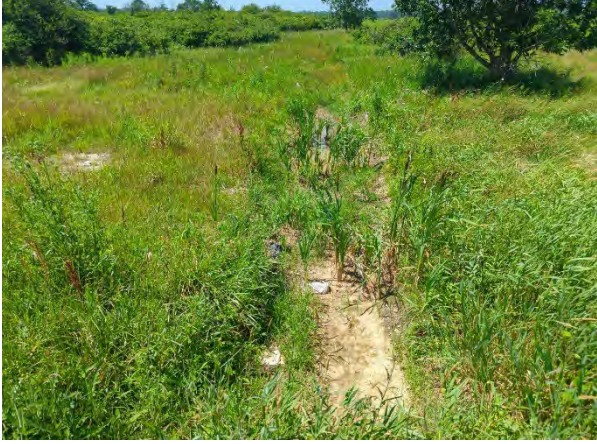
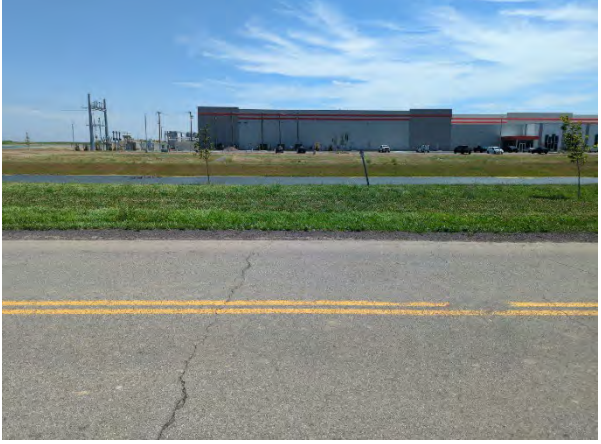
| <p><b>Photo 63</b><br/>Waypoint 26-38, Drainage Way 26, facing west.</p> | <p><b>Photo 64</b><br/>Waypoint 26-38, facing east. Drainage Way 26 begins at Crosby Road. A culvert passes under the road, draining the stormwater ditches on the east side of the road.</p> |

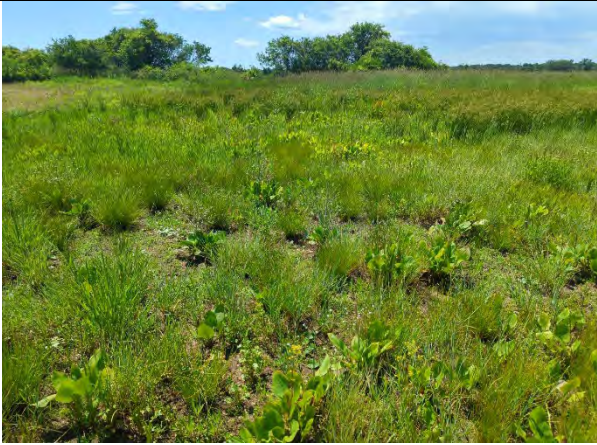
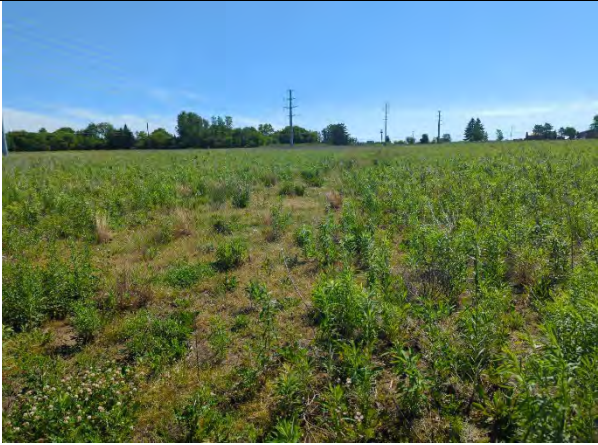
| <p><b>Photo 65</b><br/>Waypoint 26-18, Wetland 53, facing west.</p> | <p><b>Photo 66</b><br/>Waypoint 26-22, Drainage Way 29, facing northeast.</p> |

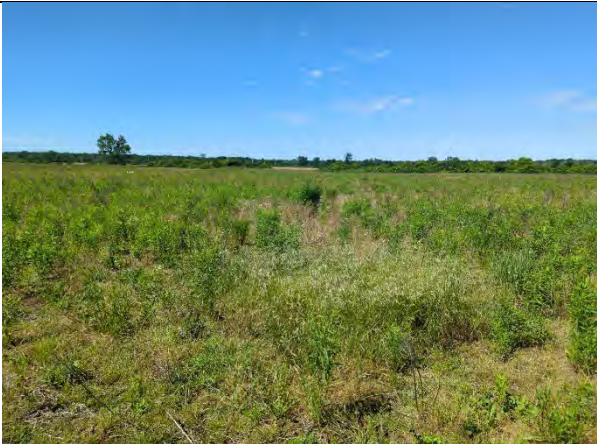
| <p><b>Photo 67</b><br/>Waypoint 26-22, Drainage Way 29, facing southwest.</p> | <p><b>Photo 68</b><br/>Waypoint 26-39, Wetland 15, facing north.</p> |

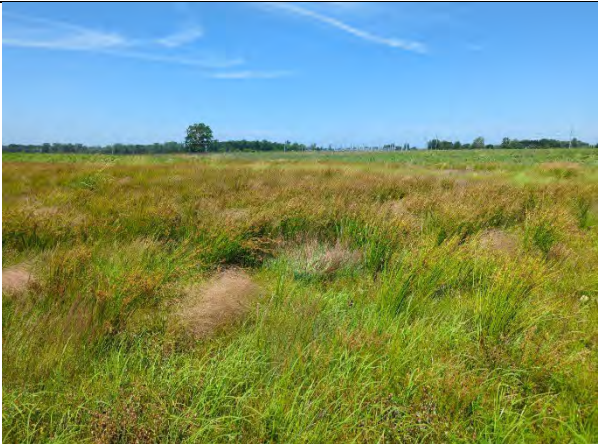
| Identifier | Wetland Area | Community Type(s)/ Comments | Data Point / Photo # | Jurisdiction |
|---|---|---|---|---|
| Wetland 15 | 0.30 | PEM Shallow Emergent Marsh within a field that had been farmed through 2025. | DP15 (2011)/ Photo 68 | NONE |

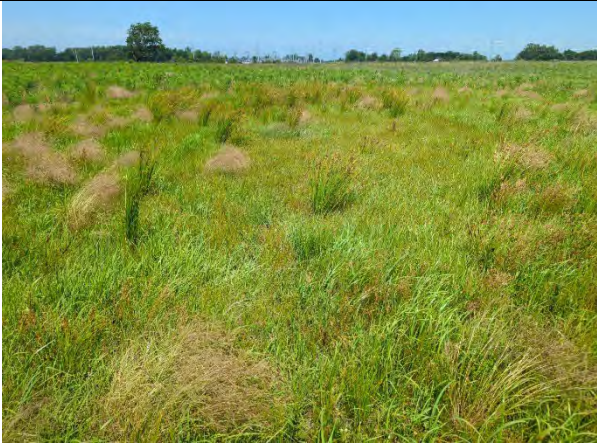
| Identifier | Wetland Area | Community Type(s)/ Comments | Data Point / Photo # | Jurisdiction |
|---|---|---|---|---|
| Wetland 16 | 0.05 | PEM Shallow Emergent Marsh within a field that had been farmed through 2025. | NA/ Photo 69 | NONE |

| <p><b>Photo 69</b><br/>Waypoint 26-43, Wetland 16, facing north.</p> | <p><b>Photo 70</b><br/>Waypoint 26-44, Wetland 14, facing southwest.</p> |

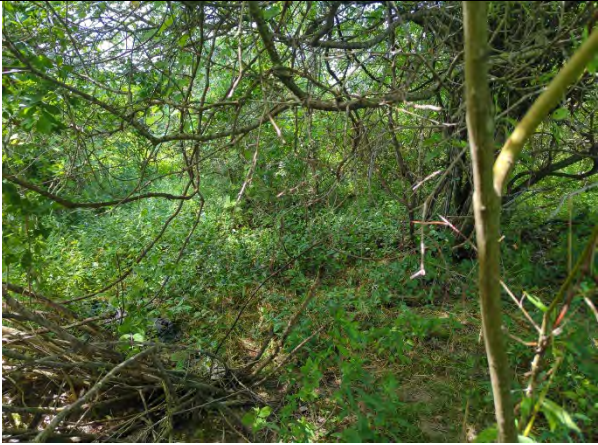
| Identifier | Wetland Area | Community Type(s)/ Comments | Data Point / Photo # | Jurisdiction |
|---|---|---|---|---|
| Wetland 14 | 0.06 | PSS Shrub Swamp, in hedgerow. Isolated | NA/ Photo 70 | NONE |

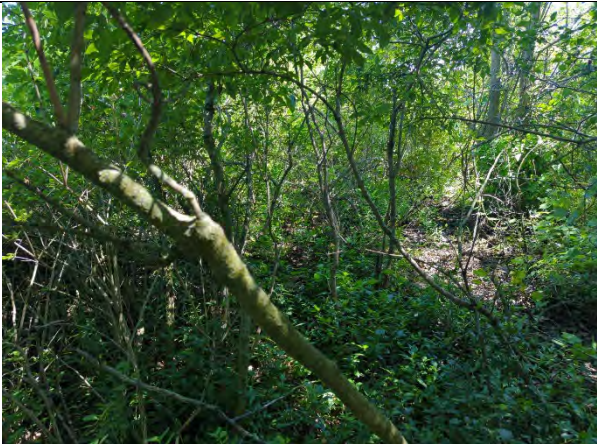
| Identifier | Wetland Area | Community Type(s)/ Comments | Data Point / Photo # | Jurisdiction |
|---|---|---|---|---|
| Wetland 13 | 0.38 | PSS Shrub Swamp, in hedgerow. Isolated. | NA/ Photo 71 | NONE |

| <p><b>Photo 71</b><br/>Waypoint 26-45, Wetland 13, facing east.</p> | <p><b>Photo 72</b><br/>Waypoint 26-46, Wetland 12, facing west.</p> |

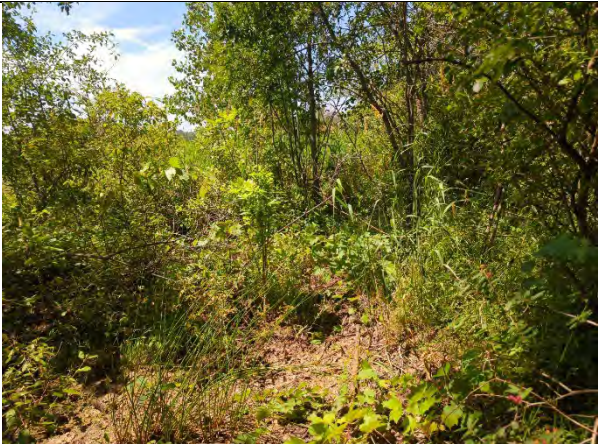
| Identifier | Wetland Area | Community Type(s)/ Comments | Data Point / Photo # | Jurisdiction |
|---|---|---|---|---|
| Wetland 12 | 0.08 | PSS Shrub Swamp, in hedgerow. Isolated. | NA/ Photo 72 | NONE |

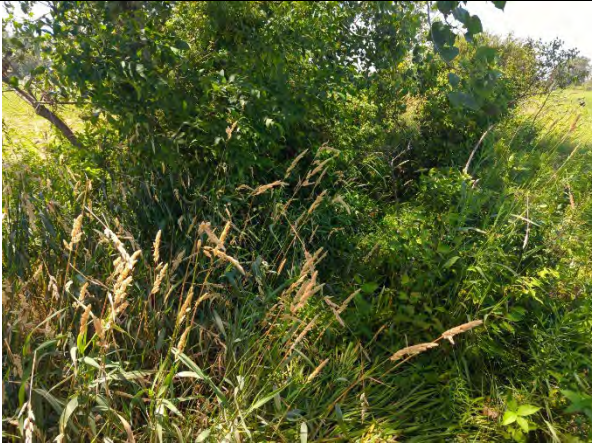
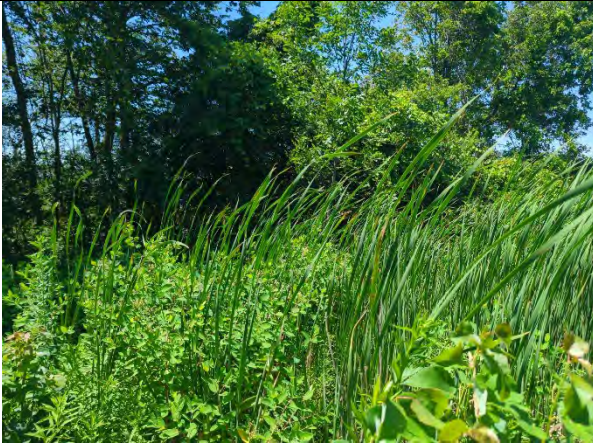
| <p><b>Photo 73</b><br/>Waypoint 26-47, Wetland 26, facing west.</p> | <p><b>Photo 74</b><br/>Waypoint 26-48, Wetland 26, facing west.</p> |

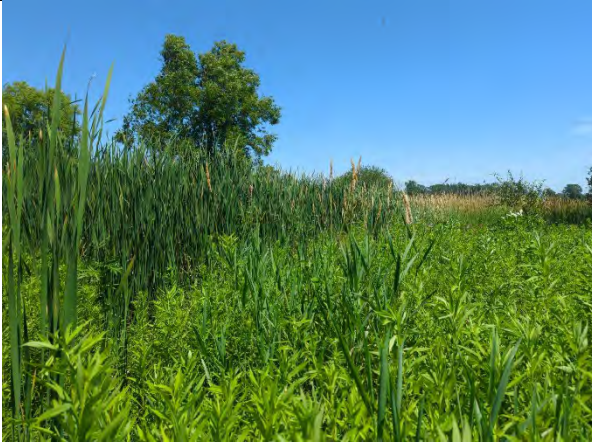
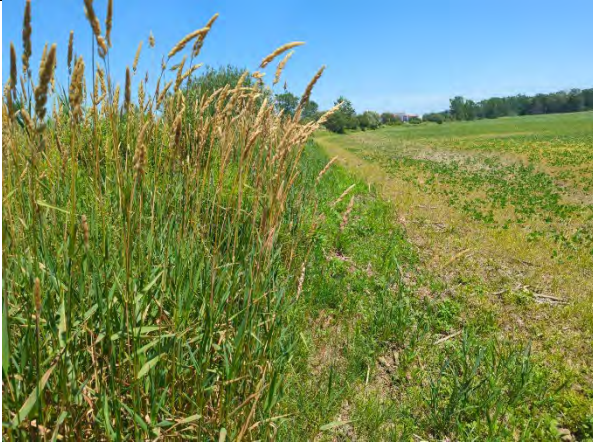
| <p><b>Photo 75</b><br/>Waypoint 26-48, Wetland 26, facing east.</p> | <p><b>Photo 76</b><br/>Waypoint 26-49, Wetland 26, facing east.</p> |

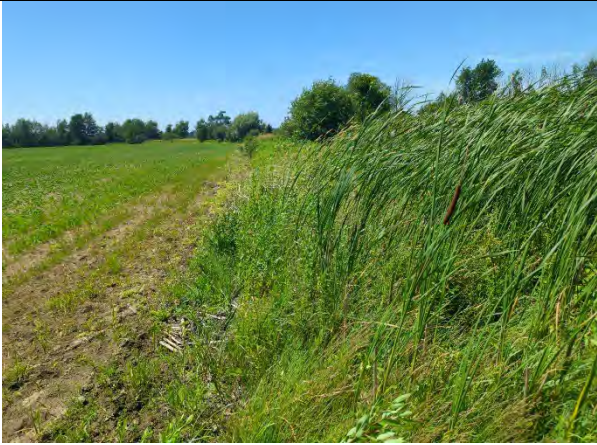
| <p><b>Photo 77</b><br/>Waypoint 26-50, Wetland 26, facing west.</p> | <p><b>Photo 78</b><br/>Waypoint 26-51, Wetland 26/Trib 3, facing west.</p> |

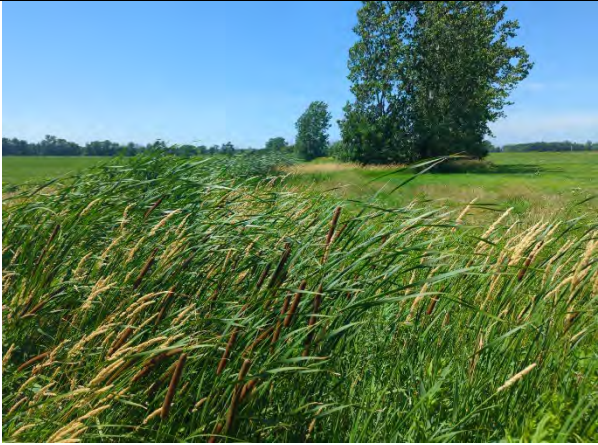
| Identifier | Length in AOI<br>(Linear Feet) | Flow Regime & Direction | Jurisdiction | Photos |
|---|---|---|---|---|
| Trib 3 | 1,900.73 | Intermittent; Flows to the NW | USACE | Photo 78 |

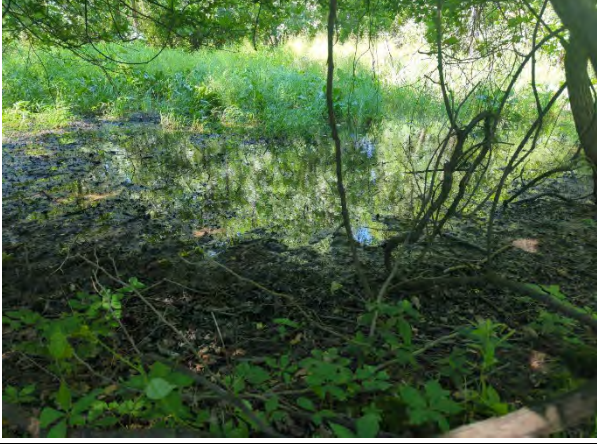
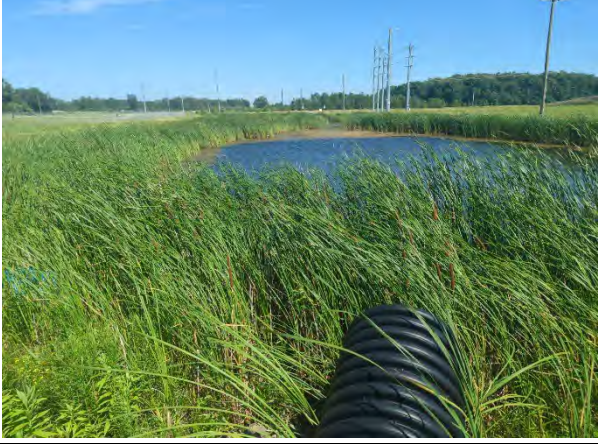
| Identifier | Wetland Area | Community Type(s)/ Comments | Data Point / Photo # | Jurisdiction |
|---|---|---|---|---|
| Stormwater Pond 1 | 0.97 | Open water pond ringed by emergent marsh. | NA/ Photo 84 | NONE |

| <p><b>Photo 83</b><br/>Waypoint 26-55, Wetland 27, facing north.</p> | <p><b>Photo 84</b><br/>Waypoint 26-56, Stormwater Pond 1, facing east.</p> |

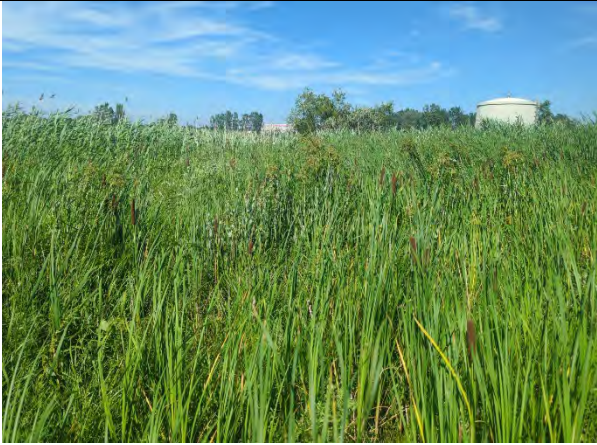
| Identifier | Wetland Area | Community Type(s)/ Comments | Data Point / Photo # | Jurisdiction |
|---|---|---|---|---|
| Wetland 54 | 0.26 | PEM lying between SP1 and farmed field. Low lying area. | NA/ Photo 85 | USACE |

| <p><b>Photo 85</b><br/>Waypoint 26-57, Wetland 54, facing northeast.</p> | <p><b>Photo 86</b><br/>Waypoint 26-70, Stormwater Pond 6, facing southeast.</p> |

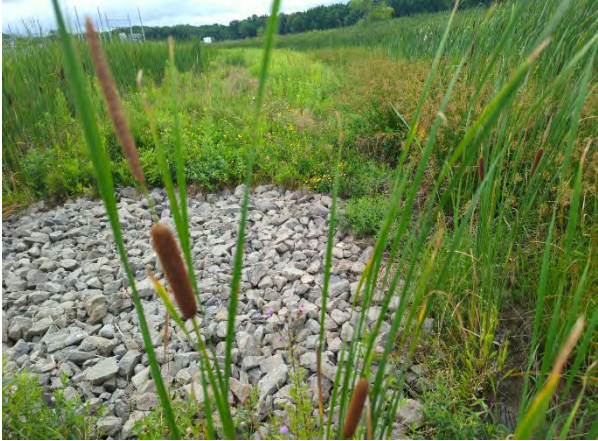
| <p><b>Photo 99</b><br/>Waypoint 26-99, Wetland 20, facing southeast.</p> | <p><b>Photo 100</b><br/>Waypoint 26-100, Wetland 20, facing southeast. Riprap marks the overflow for Stormwater Pond 6 into W20.</p> |

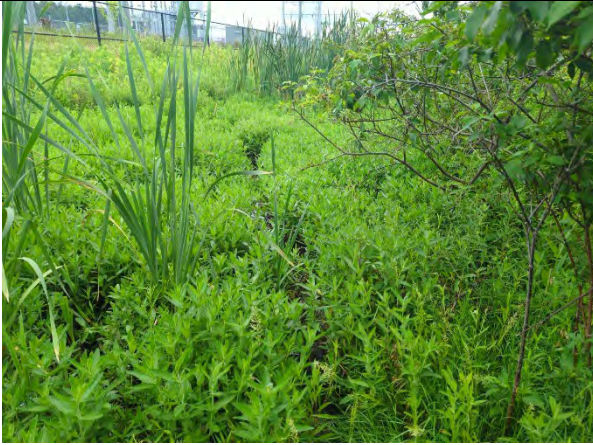
| Identifier | Length in AOI<br>(Linear Feet) | Flow Regime & Direction | Jurisdiction | Photos |
|---|---|---|---|---|
| Trib 5 | 3,309.53 | Intermittent; Flows through W36 & W20 to the NW | USACE | Photos 102, 104-107, 109, 121, |

| <p><b>Photo 101</b><br/>Waypoint 26-101, Wetland 20, facing southeast.</p> | <p><b>Photo 102</b><br/>Waypoint 26-107, Wetland 20/Trib 5, facing south.</p> |

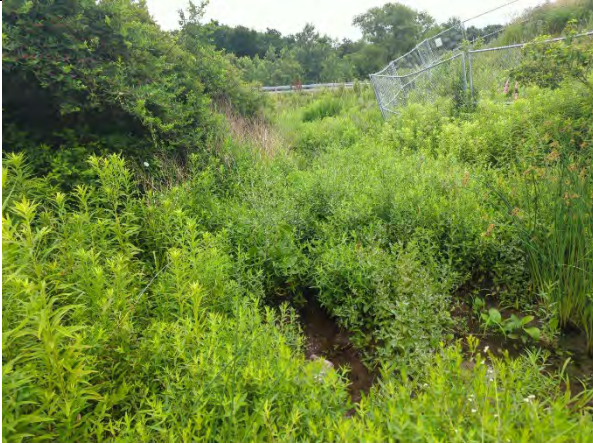
| <p><b>Photo 103</b><br/>Waypoint 26-107, Wetland 20, facing east.</p> | <p><b>Photo 104</b><br/>Waypoint 26-110, Wetland 20/Trib 5, facing southeast.</p> |

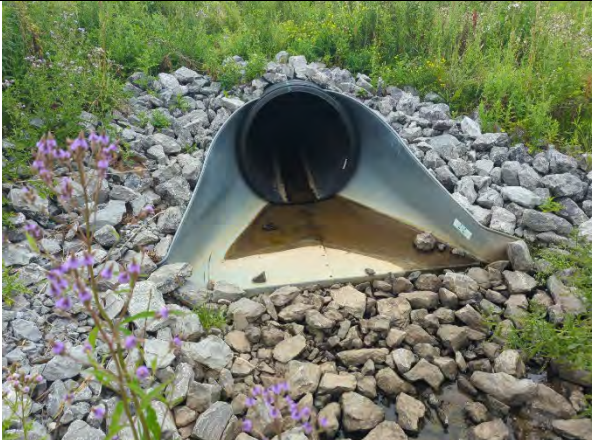
| <p><b>Photo 105</b><br/>Waypoint 26-112, Wetland 20/Trib 5, facing southeast at the culvert that was replaced a few years ago.</p> | <p><b>Photo 106</b><br/>Waypoint 26-112, Wetland 20/Trib 5, facing southwest.</p> |

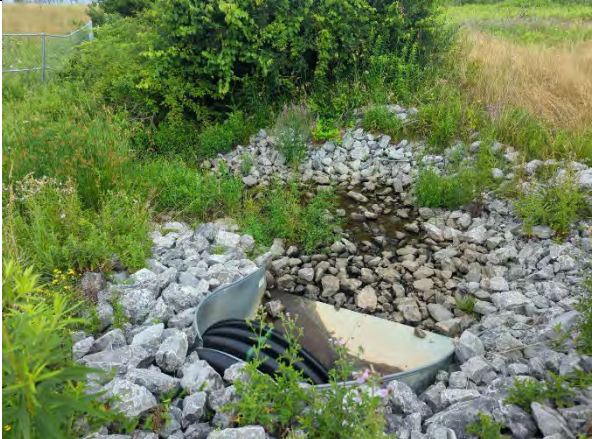
| <p><b>Photo 107</b><br/>Waypoint 26-113, Wetland 20/Trib 5, facing west.</p> | <p><b>Photo 108</b><br/>Waypoint 26-114, Wetland 20, facing northwest.</p> |

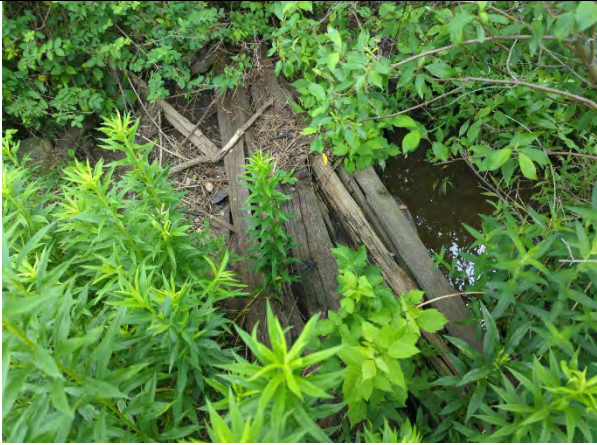
| <p><b>Photo 109</b></p> <p>Waypoint 26-115, Wetland 20, facing north.<br/>An old wooden bridge overtop of a culvert pipe within Trib 5.</p> | <p><b>Photo 110</b></p> <p>Waypoint 26-116, Wetland 20, facing east.</p> |

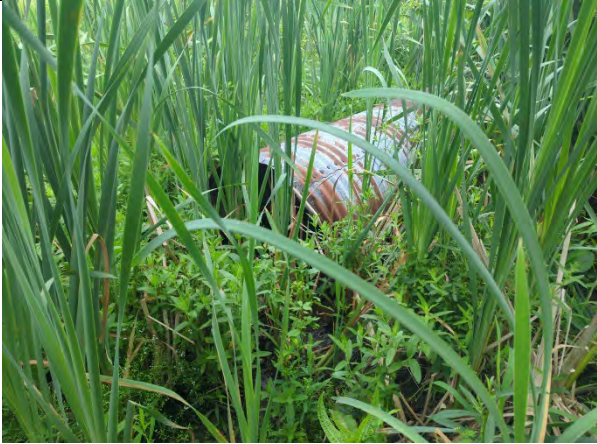
| <p><b>Photo 111</b></p> <p>Waypoint 26-117, Wetland 20, facing northeast. An old culvert pipe within the wetland.</p> | <p><b>Photo 112</b></p> <p>Waypoint 26-118, Wetland 20, facing east.</p> |

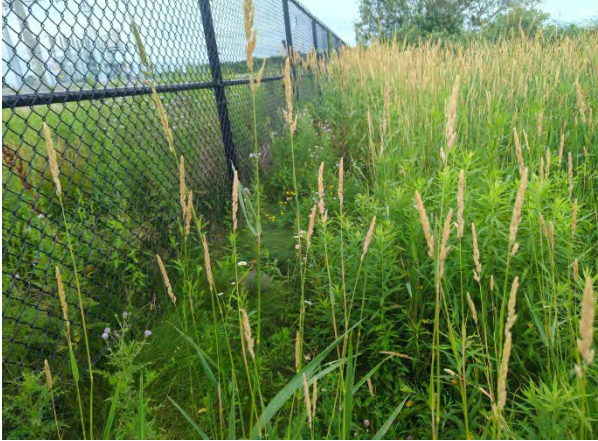
| <p><b>Photo 115</b><br/>Waypoint 26-120, Wetland 20, facing west.</p> | <p><b>Photo 116</b><br/>Waypoint 26-121, Wetland 20, facing west. Impacts to wetland here during installation of stormwater pond outlet.</p> |

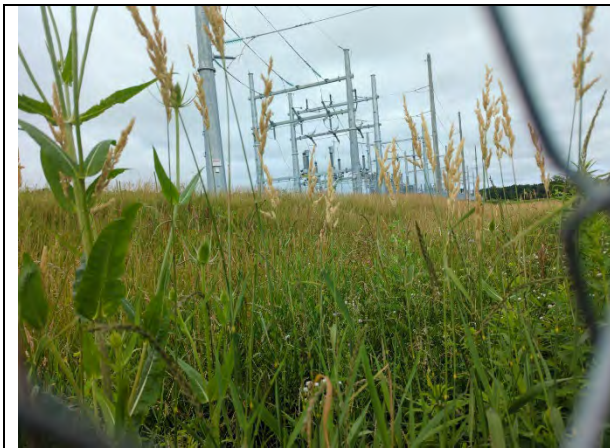
**Photo 117**

PP1, facing southwest towards the Plug Power substation. This is the 100-foot upland buffer south of Wetland 20/ Tributary 5.

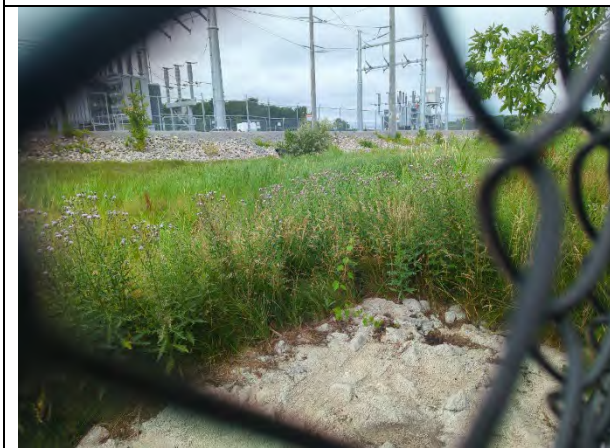
**Photo 118**

PP1, facing southeast into the Plug Power property. This is the 100-foot upland buffer south of Wetland 20/ Tributary 5.

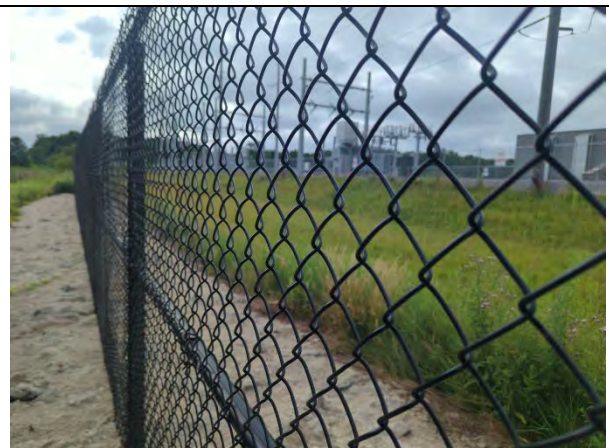
**Photo 119**

PP2, facing southwest towards the Plug Power substation. This is the 100-foot upland buffer south of Wetland 20/ Tributary 5.

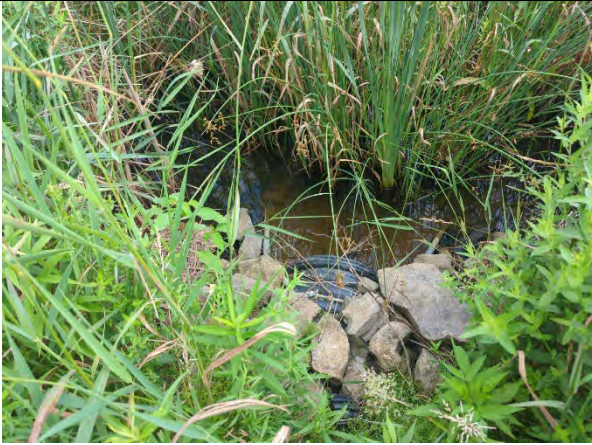
| <p><b>Photo 121</b><br/>Waypoint 26-122, Wetland 20, facing north.<br/>Outlet pipe for Stormwater Pond 5 into Trib<br/>5.</p> | <p><b>Photo 122</b><br/>Waypoint 26-124, Wetland 20, facing east.<br/>Impacts to wetland here during installation<br/>of stormwater pond outlet.</p> |

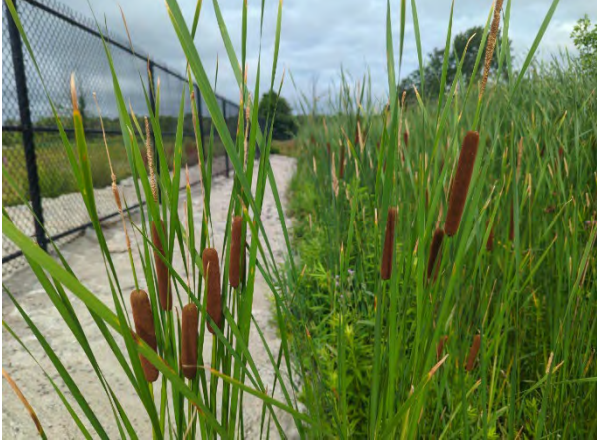
| <p><b>Photo 127</b><br/>Waypoint 26-132, Wetland 20, facing west.<br/>Impacts to wetland here from fence<br/>installation.</p> | <p><b>Photo 128</b><br/>Waypoint 26-135, Wetland 20, facing<br/>northwest.</p> |

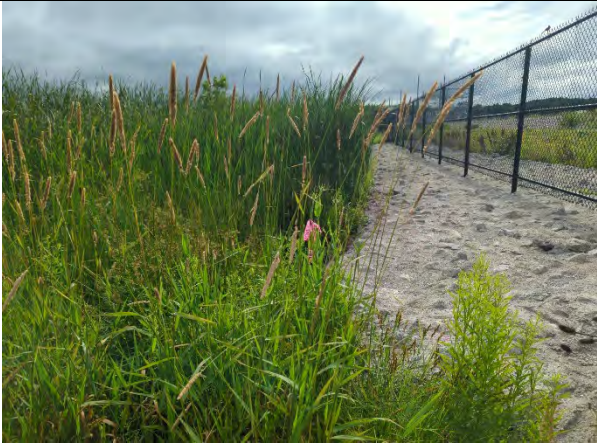
| <p><b>Photo 129</b><br/>Waypoint 26-135, Wetland 20, facing east.<br/>Impacts to wetland here from fence installation.</p> | <p><b>Photo 130</b><br/>Waypoint 26-140, Wetland 20, facing northwest.</p> |

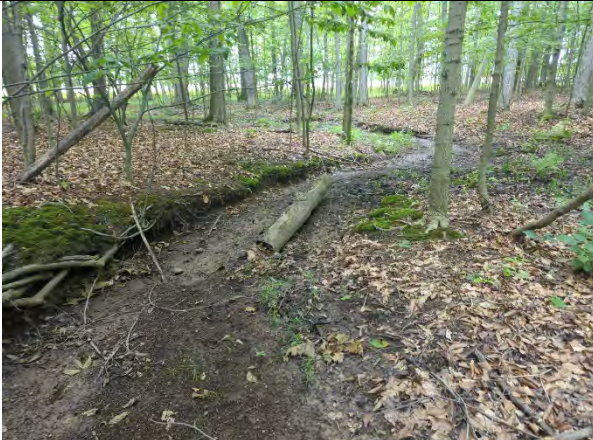
| <p><b>Photo 135</b><br/>Waypoint 26-143, Wetland 20, facing northwest.</p> | <p><b>Photo 136</b><br/>Waypoint 26-146, Trib 6 rerouted within the Plug Power Site, facing northwest.</p> |

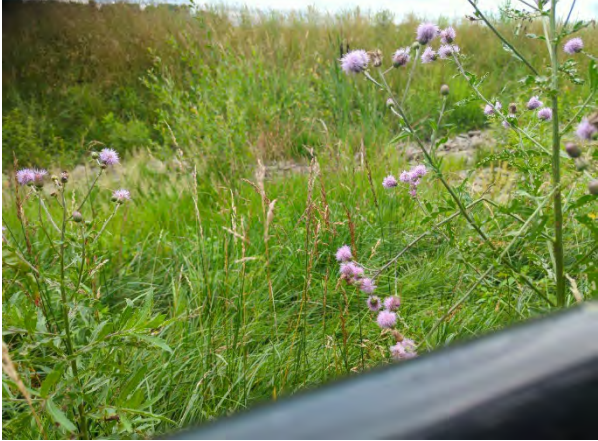
| <p><b>Photo 147</b><br/>Waypoint 26-187, Wetland 29, facing south.</p> | <p><b>Photo 148</b><br/>Waypoint 26-190, Wetland 29, facing north. Impacts to the wetland within this area due to fence installation.</p> |

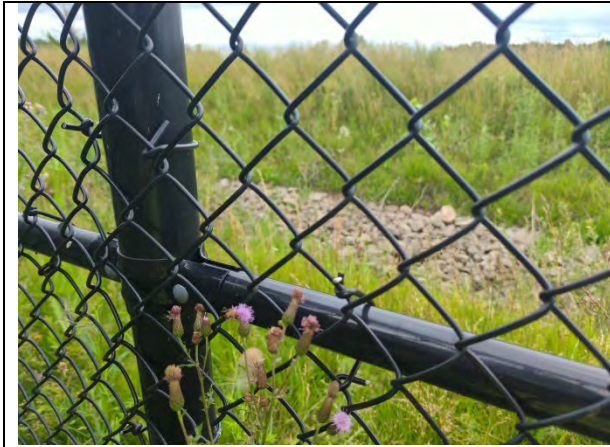
**Photo 149**

Waypoint 26-191, Wetland 29, facing northwest. Impacts to the wetland within this area due to fence installation.

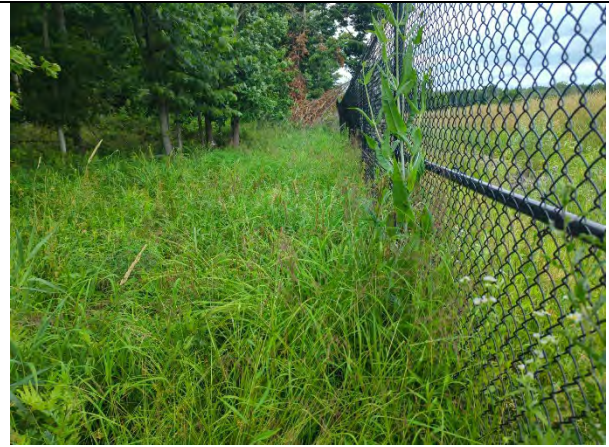
**Photo 150**

Waypoint 26-191, Wetland 29, facing west. Impacts to the wetland within this area due to fence installation.

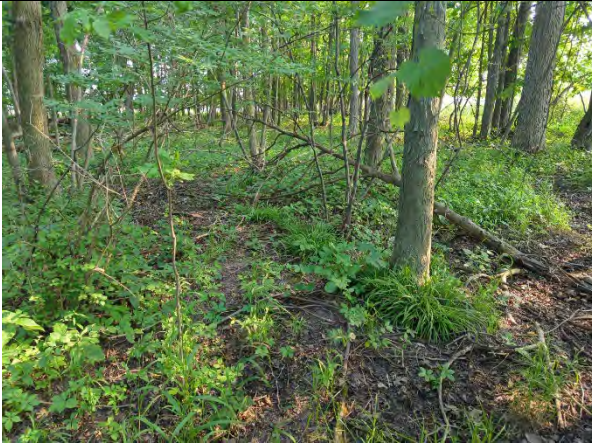
| <p><b>Photo 157</b><br/>Waypoint 26-204, Wetland 28, facing northeast.</p> | <p><b>Photo 158</b><br/>Waypoint 26-205, facing north, looking at the swale (DW28) that drains Wetland 37 into Tributary 5.</p> |

| Identifier | Wetland Area | Community Type(s)/ Comments | Data Point / Photo # | Jurisdiction |
|---|---|---|---|---|
| Wetland 28 | 0.02 | PFO Hardwood swamp, small. Isolated. | NA/ Photo 157 | NONE |

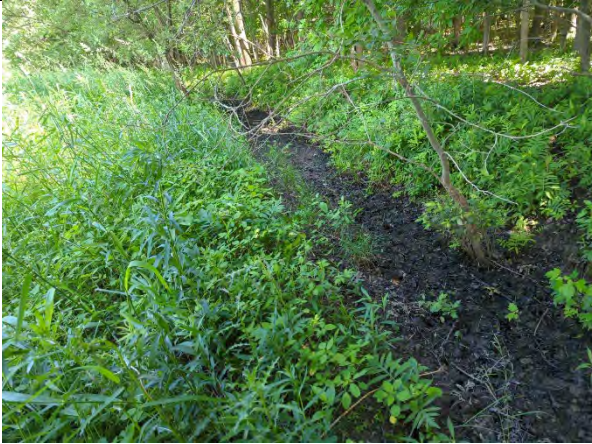
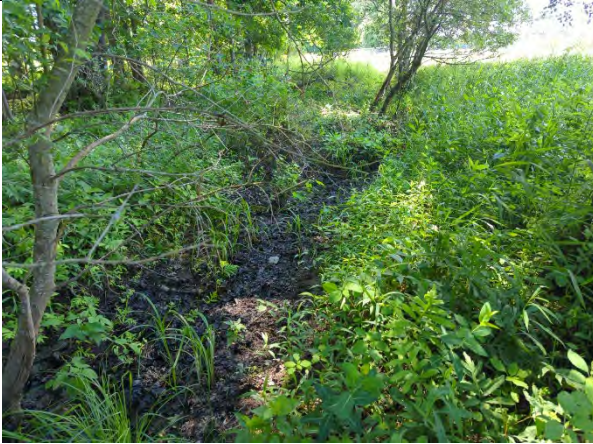
| <p><b>Photo 159</b><br/>Waypoint 26-209, Wetland 37, facing east.</p> | <p><b>Photo 160</b><br/>Waypoint 26-209, Wetland 37, facing west.</p> |

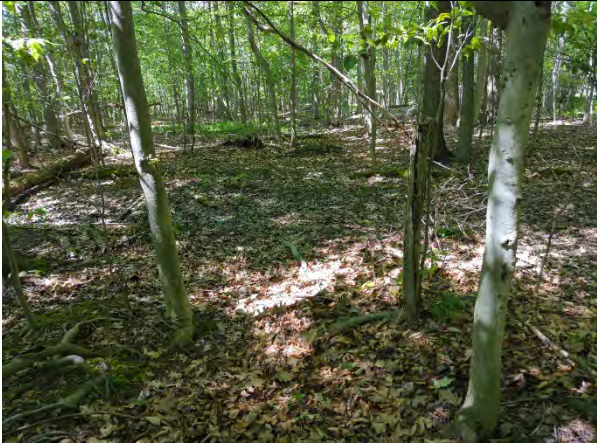
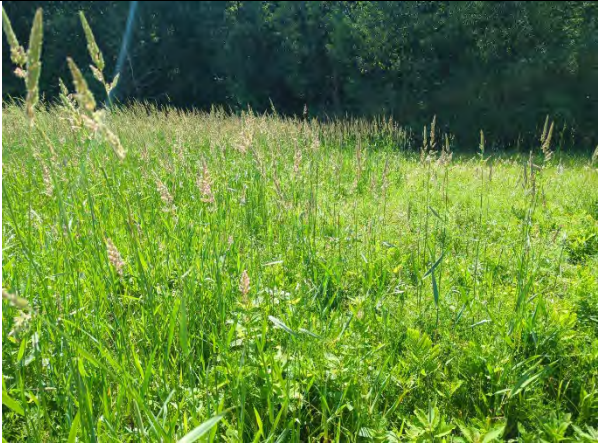
| <p><b>Photo 161</b><br/>Waypoint 26-210, Wetland 37, facing northwest.</p> | <p><b>Photo 162</b><br/>Waypoint 26-211, Wetland 37, facing west.</p> |

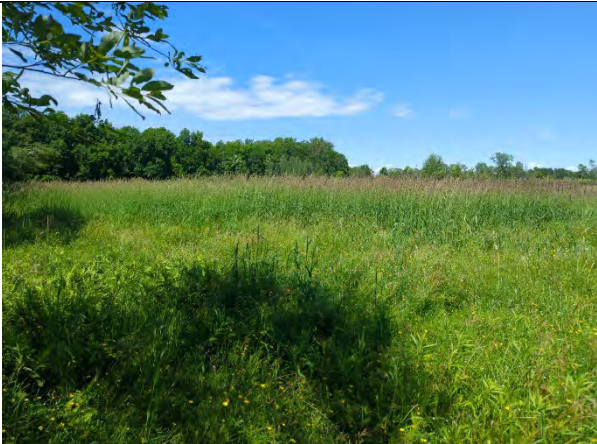
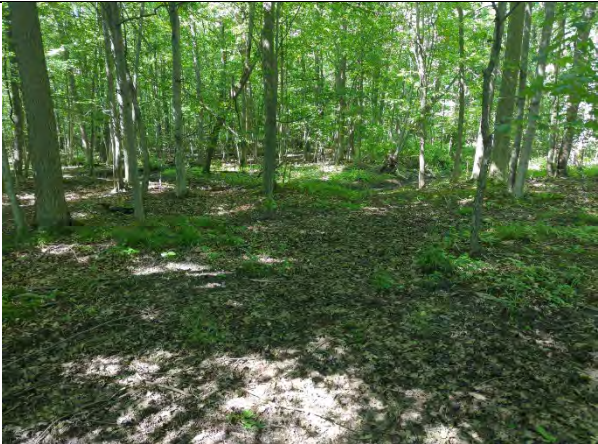
| <p><b>Photo 163</b><br/>Waypoint 26-212, Wetland 37, facing northeast.</p> | <p><b>Photo 164</b><br/>Waypoint 26-213, Wetland 36, facing north.</p> |

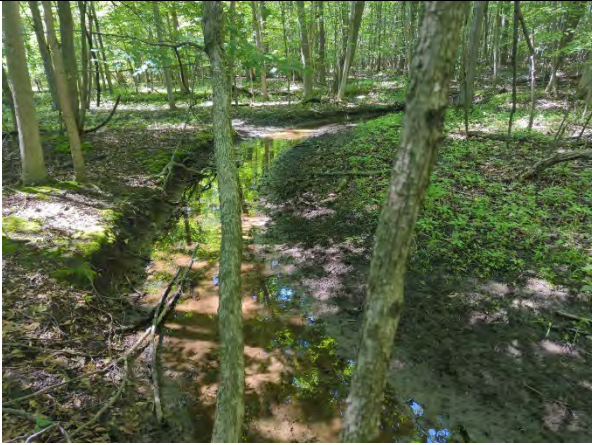
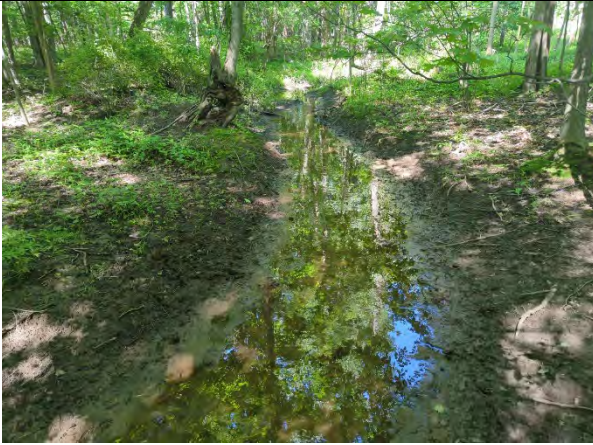
| <p><b>Photo 165</b><br/>Waypoint 26-214, Wetland 36/Tributary 5,<br/>facing southwest.</p> | <p><b>Photo 166</b><br/>Waypoint 26-214, Wetland 36/Tributary 5,<br/>facing northeast.</p> |

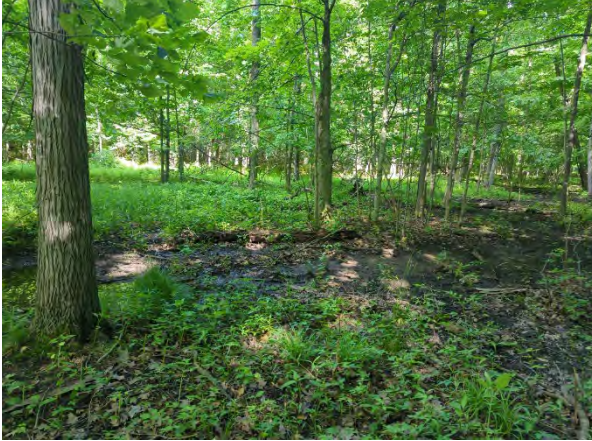
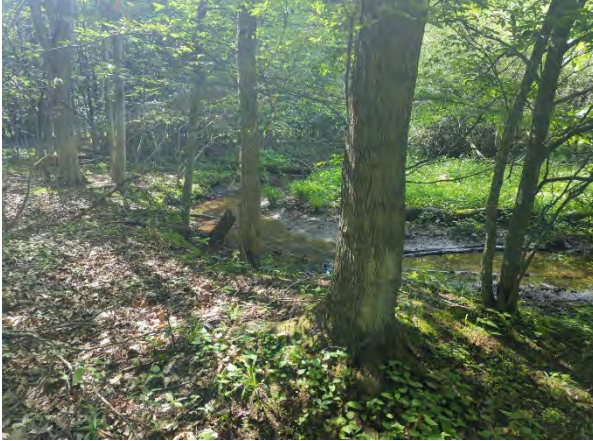
| <p><b>Photo 167</b><br/>Waypoint 26-215, Wetland 36, facing east.</p> | <p><b>Photo 168</b><br/>Waypoint 26-216, Wetland 36/Tributary 5,<br/>facing northwest.</p> |

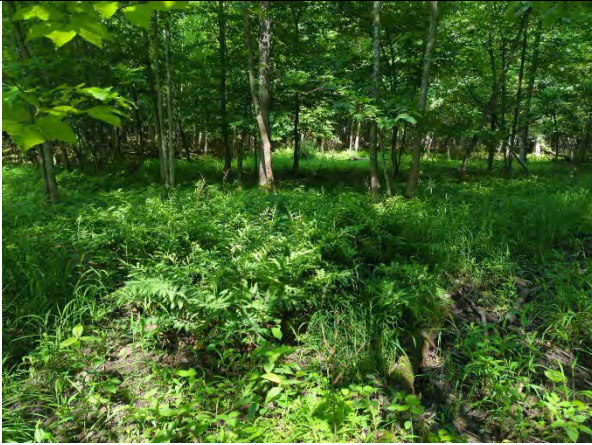
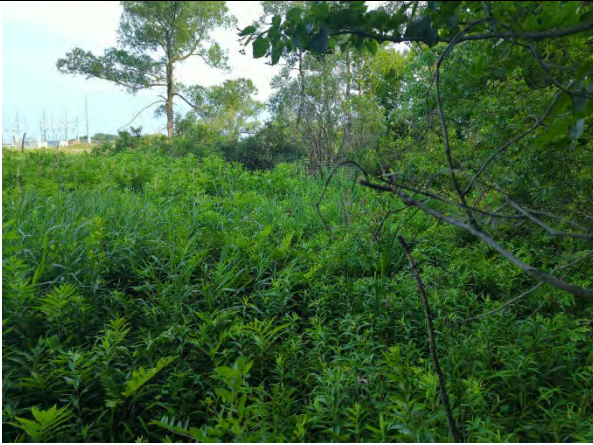
| <p><b>Photo 169</b><br/>Waypoint 26-216, Wetland 36, facing east.</p> | <p><b>Photo 170</b><br/>Waypoint 26-218, Wetland 36, facing northwest.</p> |

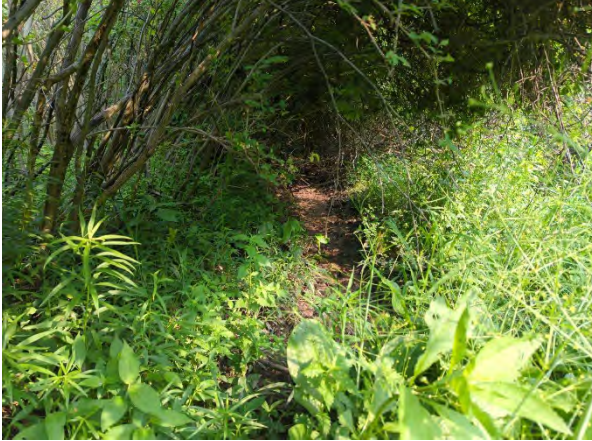
| <p><b>Photo 171</b><br/>Waypoint 26-219, Wetland 36, facing northwest.</p> | <p><b>Photo 172</b><br/>Waypoint 26-220, Wetland 36/Tributary 5, facing north at the culvert that was replaced a few years ago.</p> |

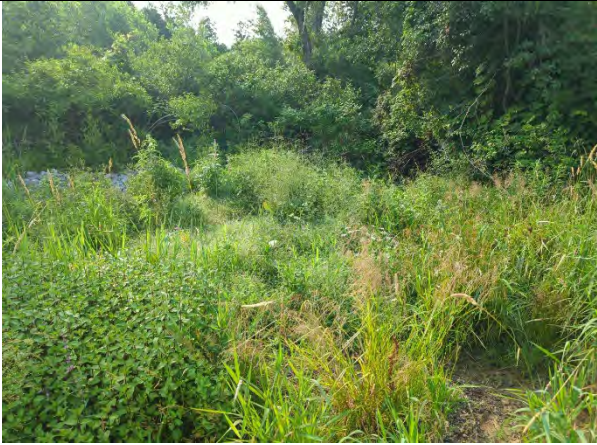
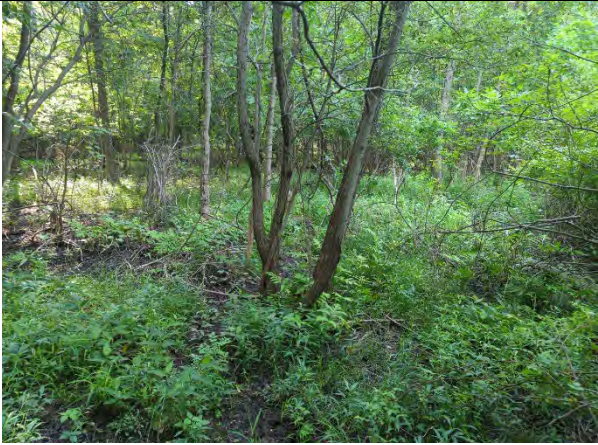
| <p><b>Photo 173</b></p> <p>Waypoint 26-220 Waypoint 26-220,<br/>Wetland 36/Tributary 5, facing southeast.</p> | <p><b>Photo 174</b></p> <p>Waypoint 26-225, Wetland 36, facing east.</p> |

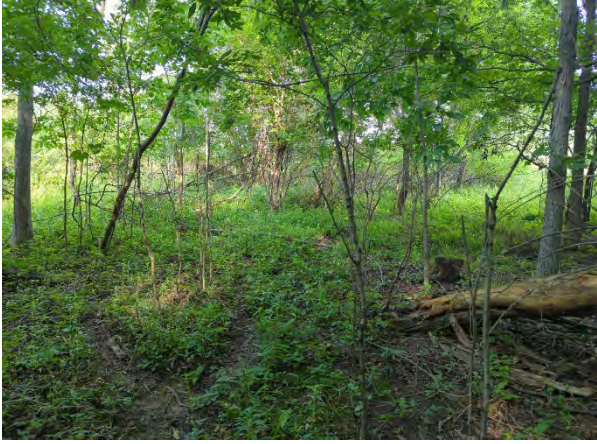
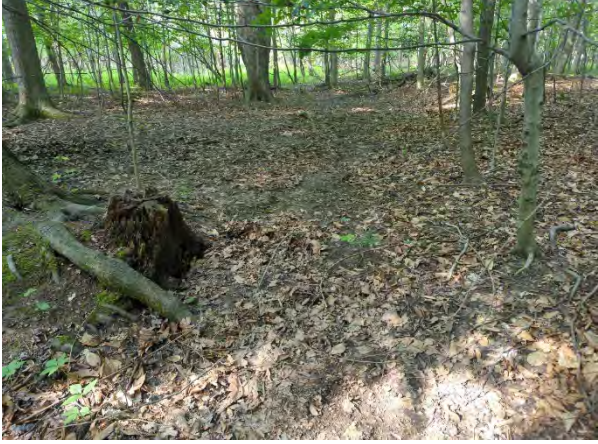
| <p><b>Photo 175</b></p> <p>Waypoint 26-225, Wetland 36, facing west.</p> | <p><b>Photo 176</b></p> <p>Waypoint 26-226, Wetland 36, facing<br/>southwest.</p> |

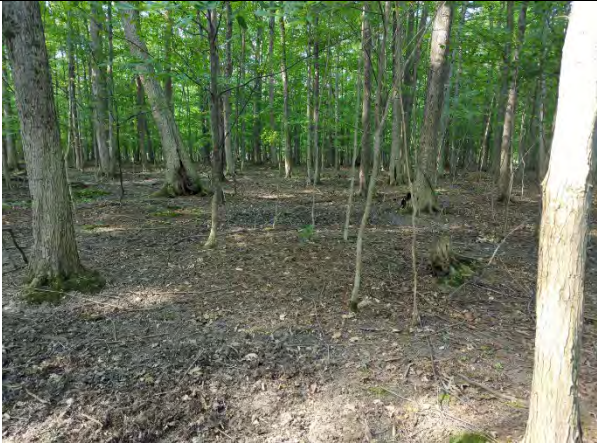
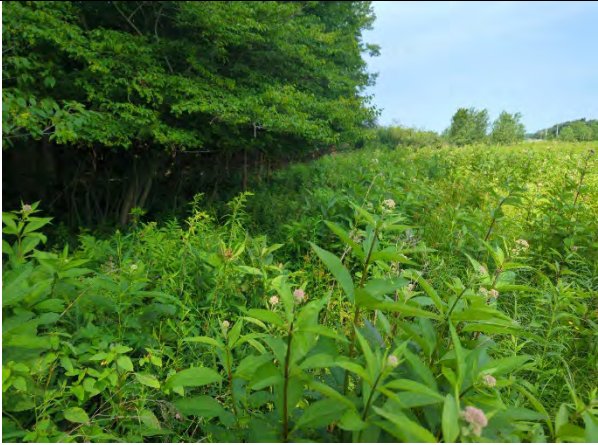
| <p><b>Photo 177</b><br/>Waypoint 26-227, Wetland 36, facing south.</p> | <p><b>Photo 178</b><br/>Waypoint 26-228, Wetland 36, facing west.</p> |

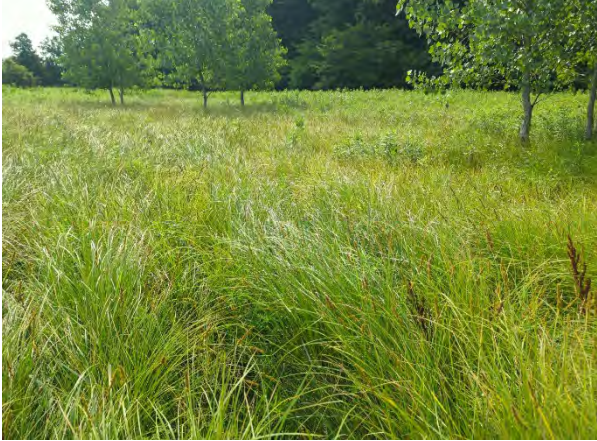
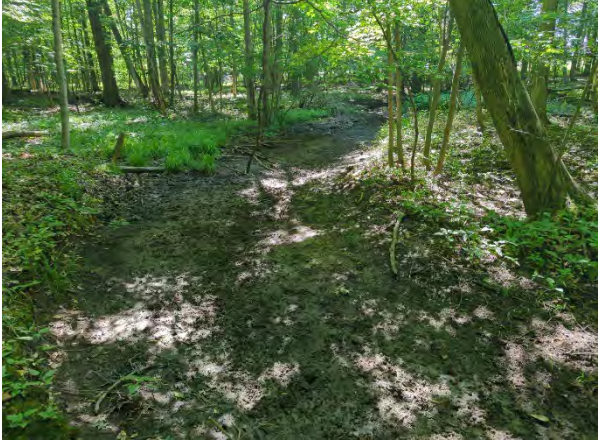
| <p><b>Photo 179</b><br/>Waypoint 26-229, Wetland 36, facing southeast.</p> | <p><b>Photo 180</b><br/>Waypoint 26-232, Wetland 36, facing southeast.</p> |
