**PHASE IA CULTURAL RESOURCE INVESTIGATION
FOR THE PROPOSED**

**WESTERN NEW YORK SCIENCE & TECHNOLOGY
ADVANCED MANUFACTURING PARK**

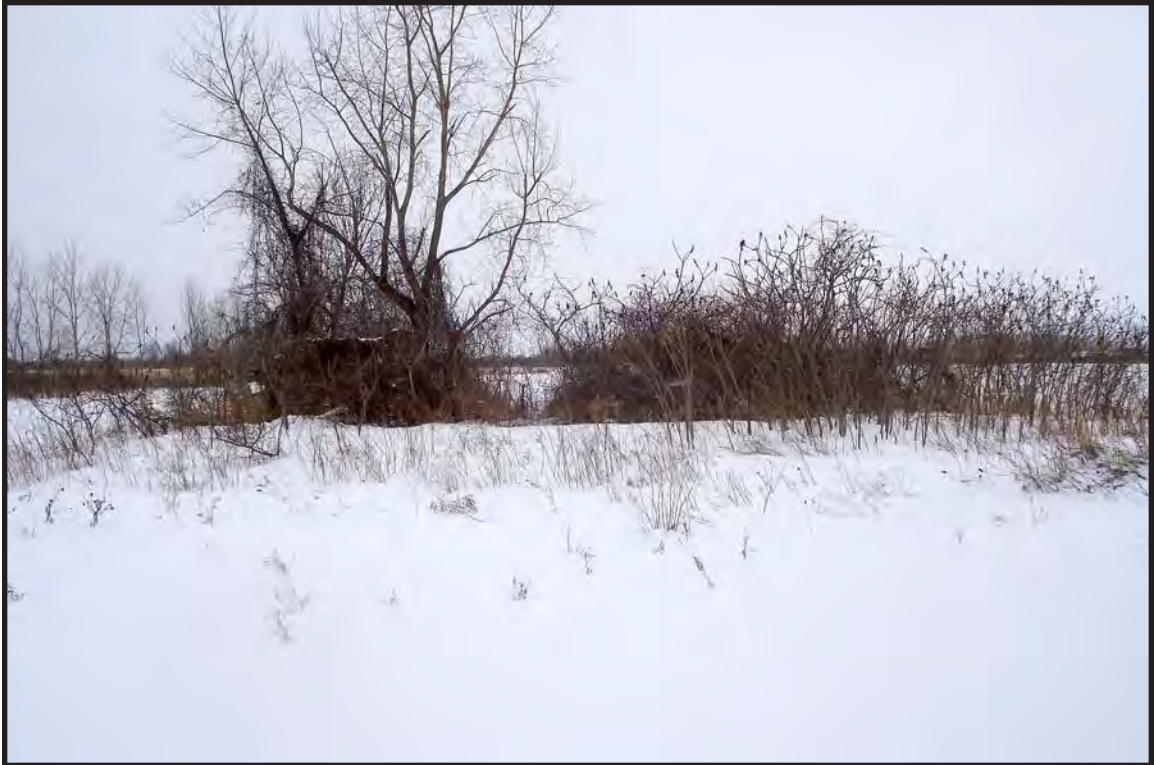
Photo 21. Facing northeast from Crosby Rd showing barn foundation 50+ years old (B: 9). This barn foundation is within the project area. On the 1866 and 1904 historic maps, the barn is located on the W. Donnan and S. Hoover property (Figures 3 and 7).

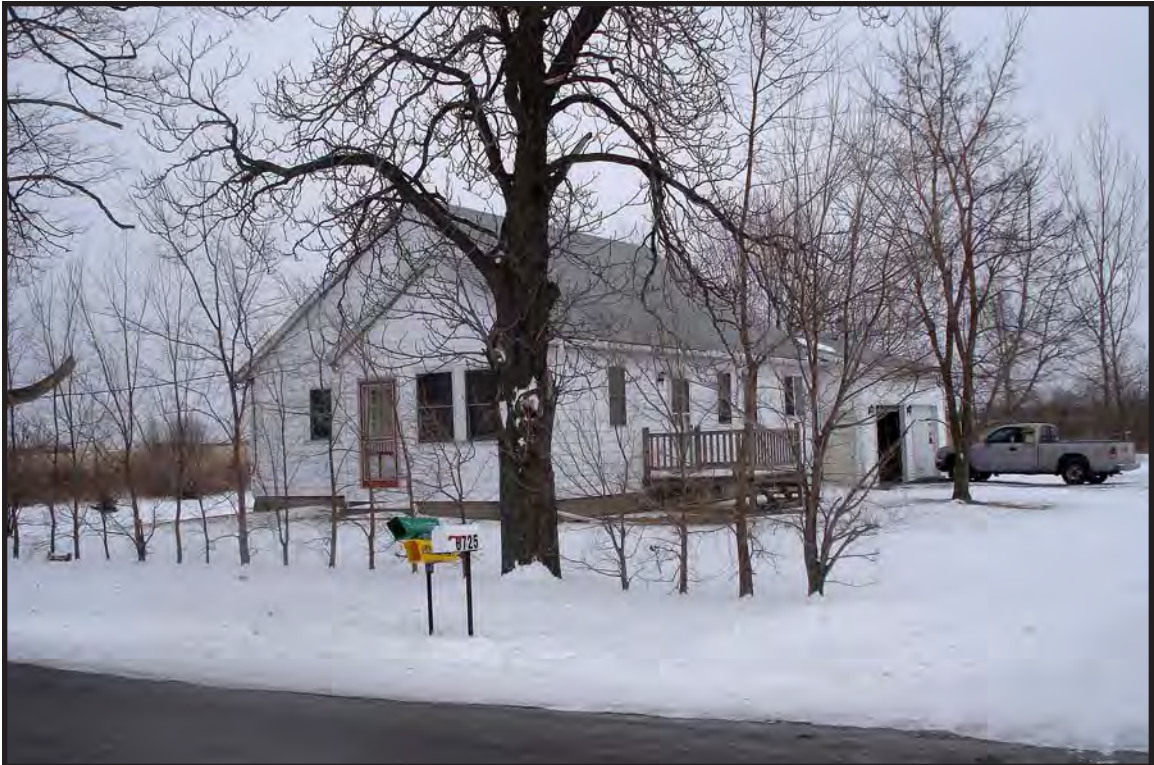
Photo 22. Facing northeast from Crosby Rd showing house #6725 (B: 9). This house is within the project area and appears to be 50+ years old. The W. Donnan and S. Hoover residence is indicated at this location on the 1866 and 1904 historic maps (Figures 3 and 7).

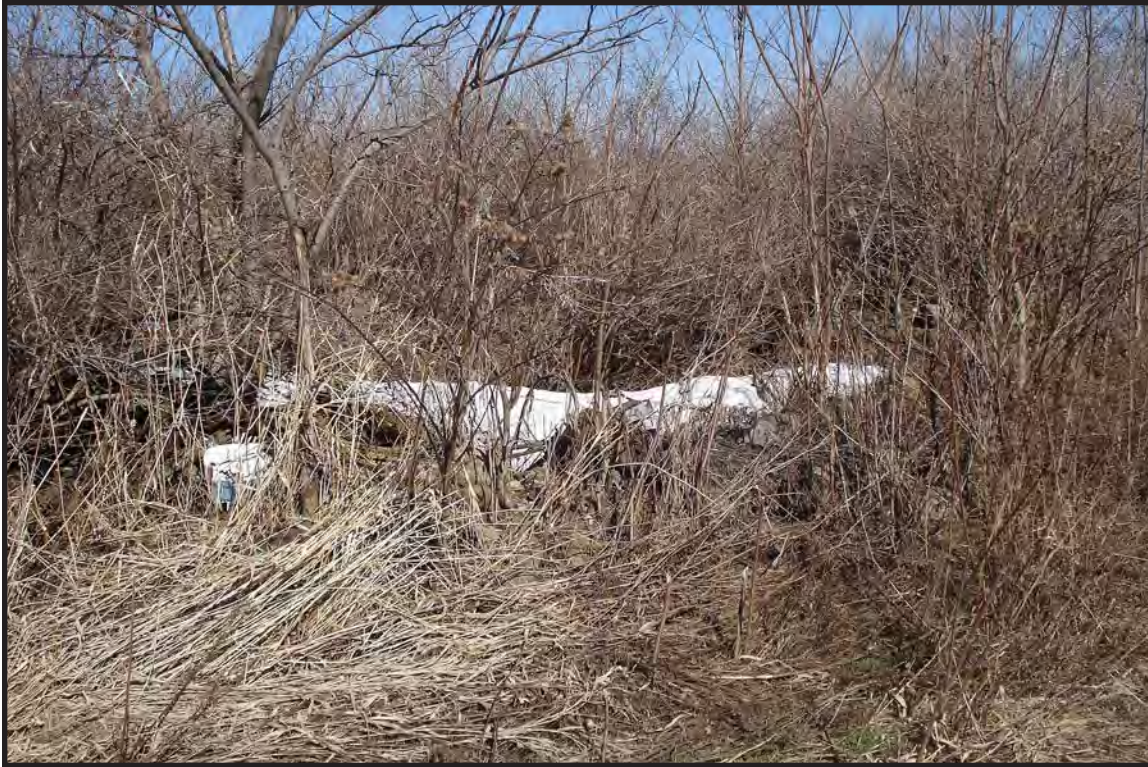
Photo 95. Facing northeast along Patterson Rd (abandoned) showing house foundation within project area at location of the J. Patterson and W. Patterson farmstead as indicated on the 1866 and 1904 historic maps (Figures 3 and 7; Attachment B: 9).

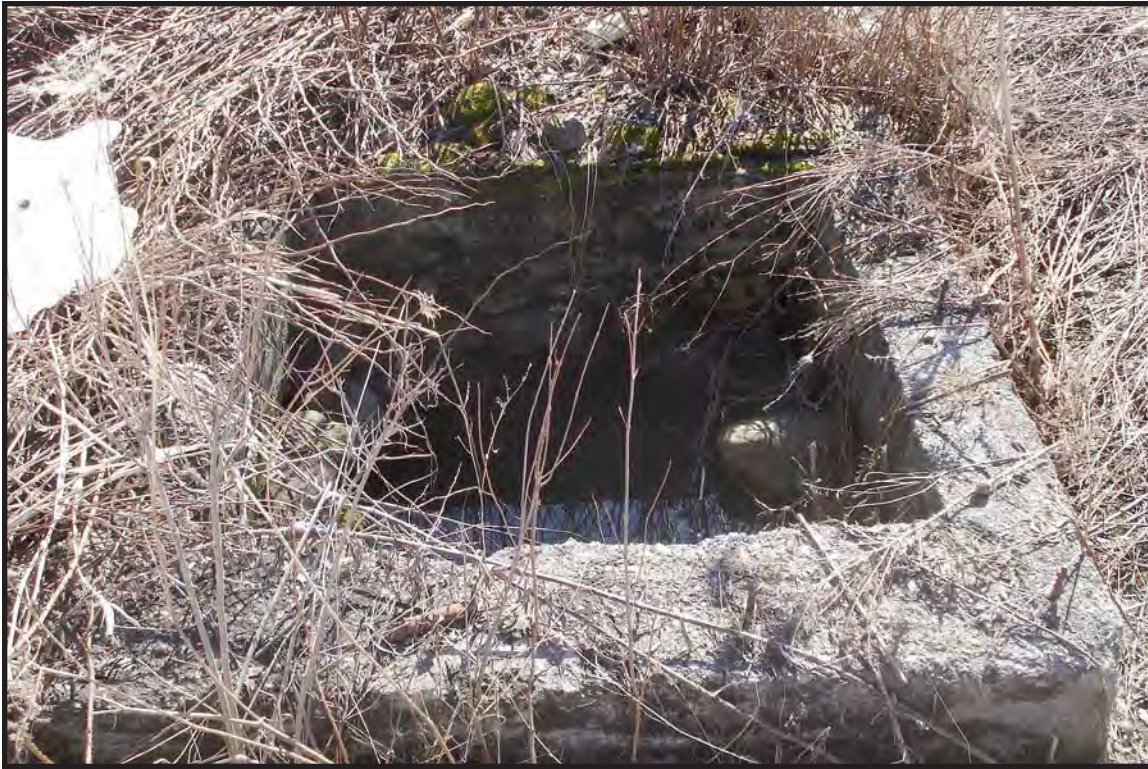
Photo 96. Facing south showing feature within project area at location of the J. Patterson and W. Patterson farmstead as indicated on the 1866 and 1904 historic maps (Figures 3 and 7; Attachment B: 9).

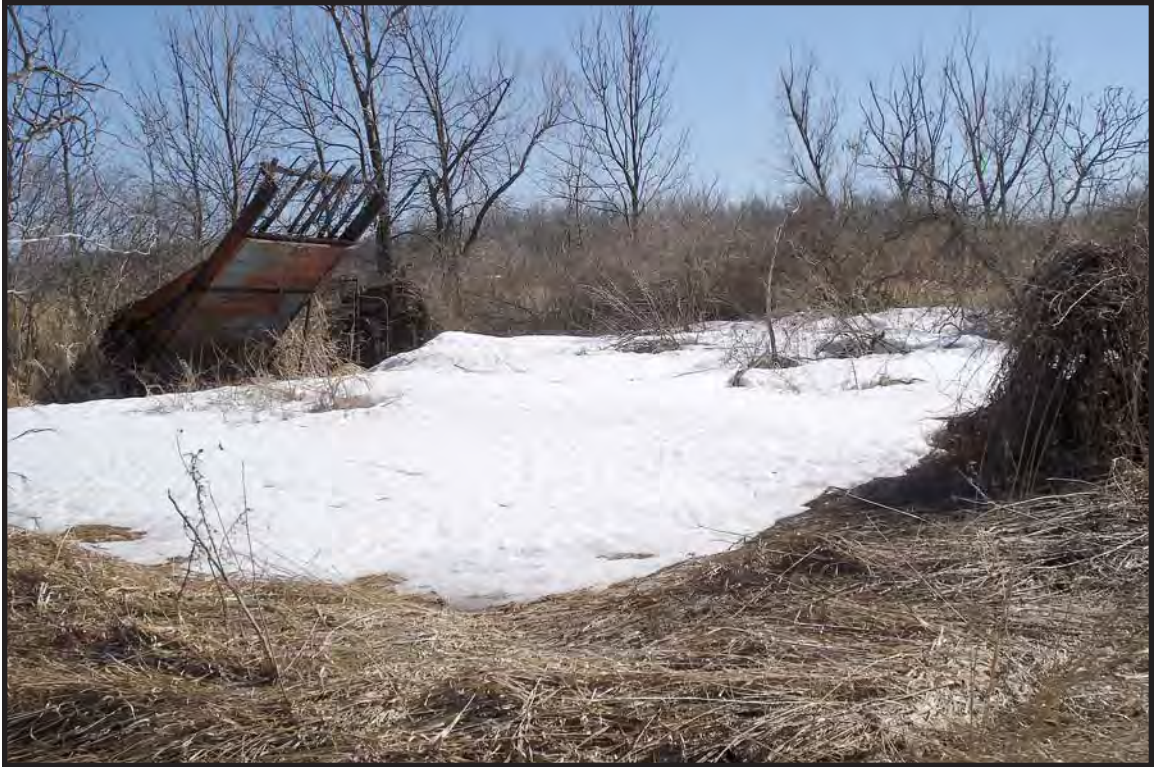
Photo 97. Facing southeast showing barn foundation and farm equipment within project area at location of the J. Patterson and W. Patterson farmstead as indicated on the 1866 and 1904 historic maps (Figures 3 and 7; Attachment B: 9).

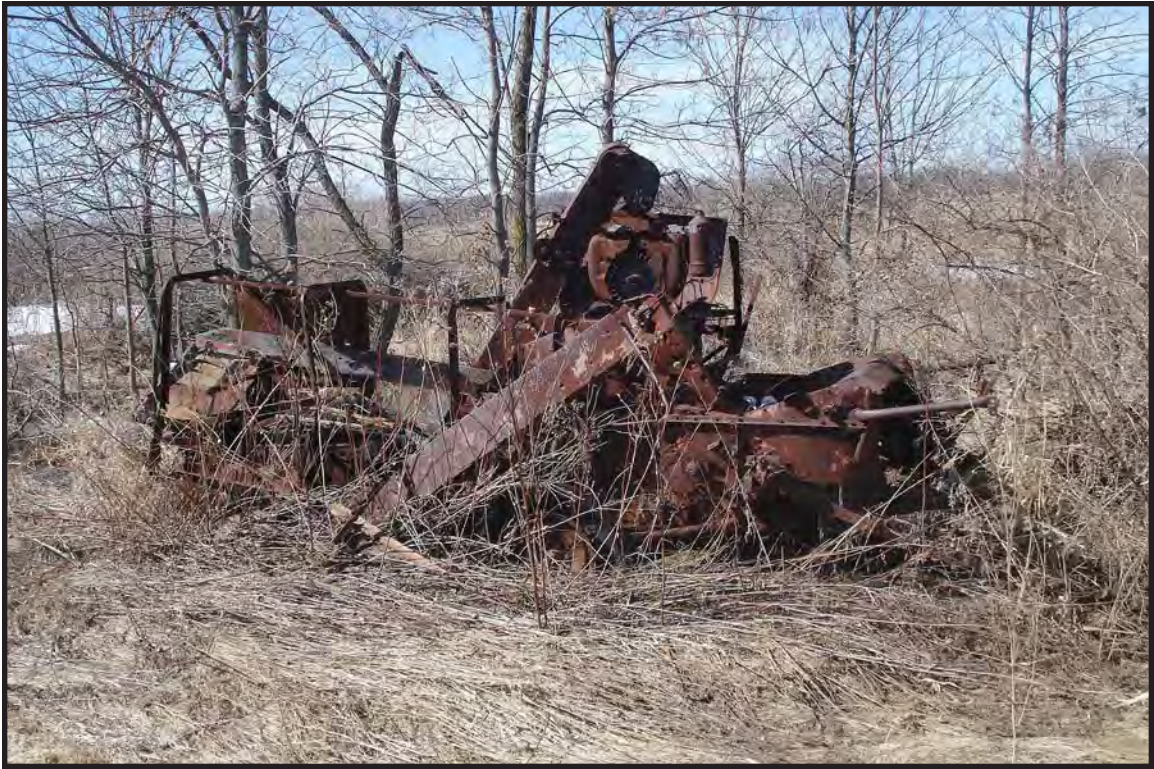
Photo 98. Facing northwest showing farm equipment within project area at location of the J. Patterson and W. Patterson farmstead as indicated on the 1866 and 1904 historic maps (Figures 3 and 7; Attachment B: 9).

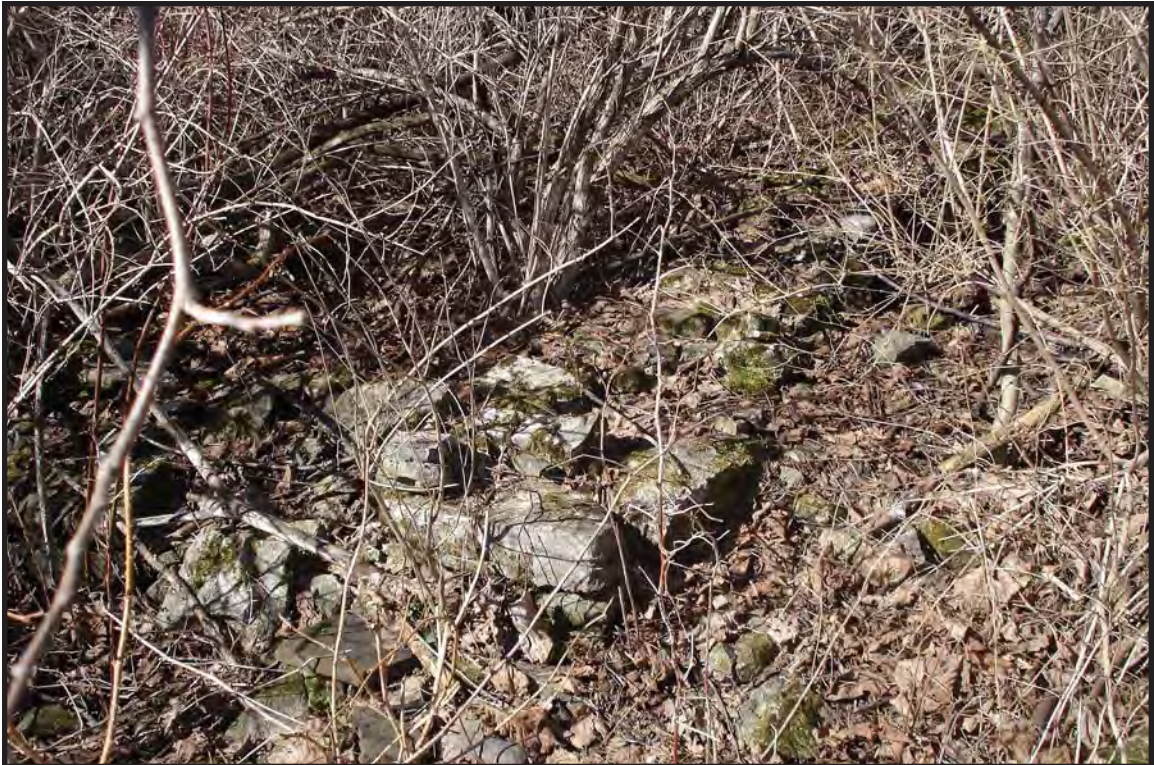
Photo 102. Facing northwest along Patterson Rd (abandoned) showing foundation within project area at location of the H. Patterson farmstead as indicated on the 1904 historic map (Figure 7; Attachment B: 10).

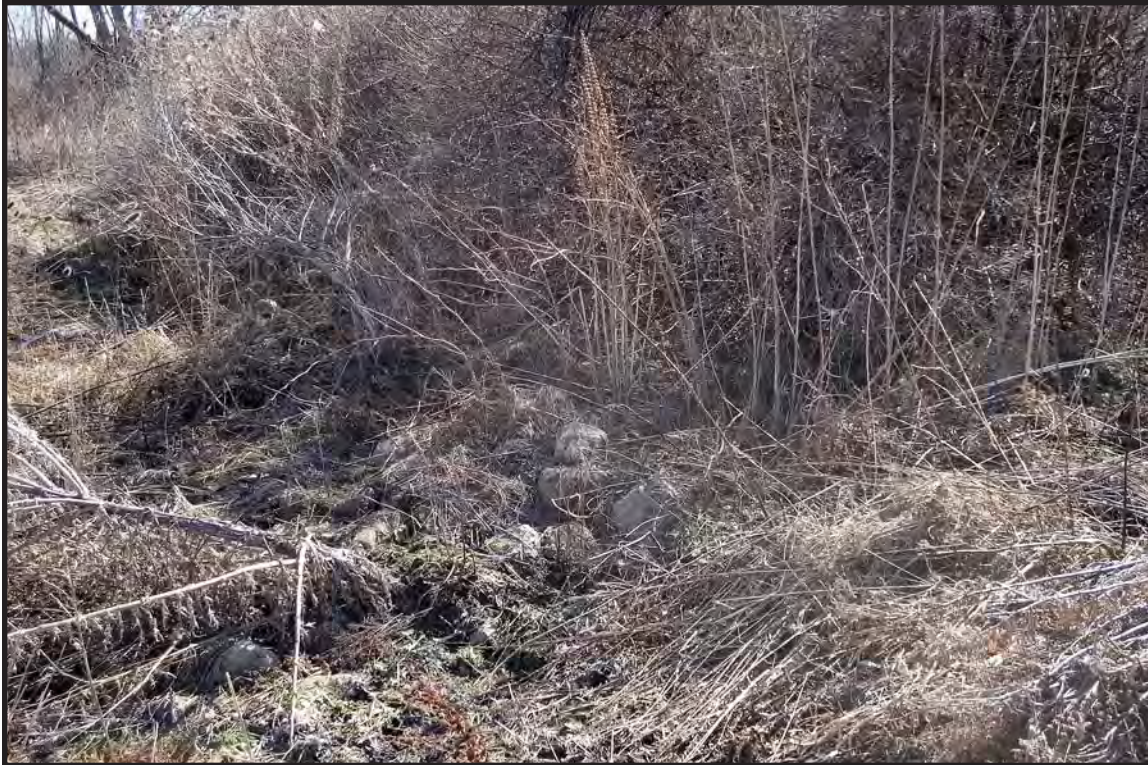
Photo 103. Facing south showing foundation within project area at location of the H. Patterson farmstead as indicated on the 1904 historic map (Figure 7; Attachment B: 10).

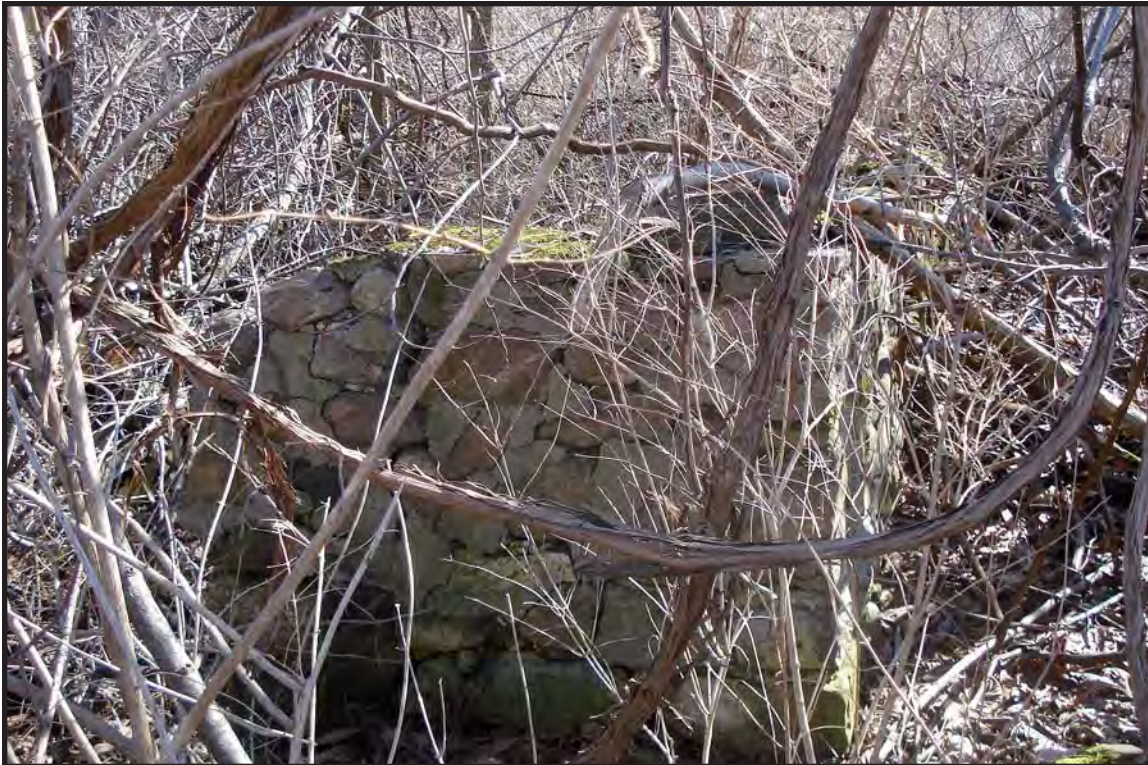
Photo 104. Facing south showing second foundation within project area at location of the H. Patterson farmstead as indicated on the 1904 historic map (Figure 7; Attachment B: 10).

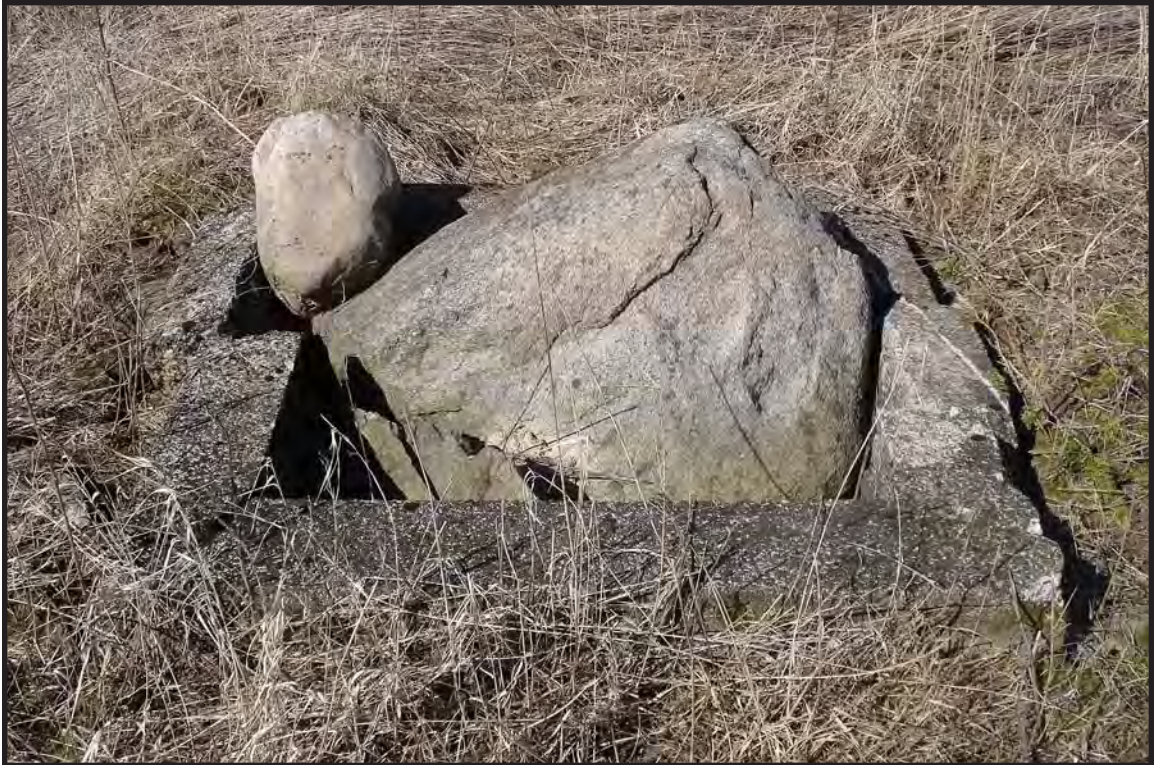
Photo 105. Facing north showing well feature within project area at location of the H. Patterson farmstead as indicated on the 1904 historic map (Figure 7; Attachment B: 10).
